Appendix B

Project Objective

Village of Riverlea, Ohio

Sanitary Sewer Evaluation Study

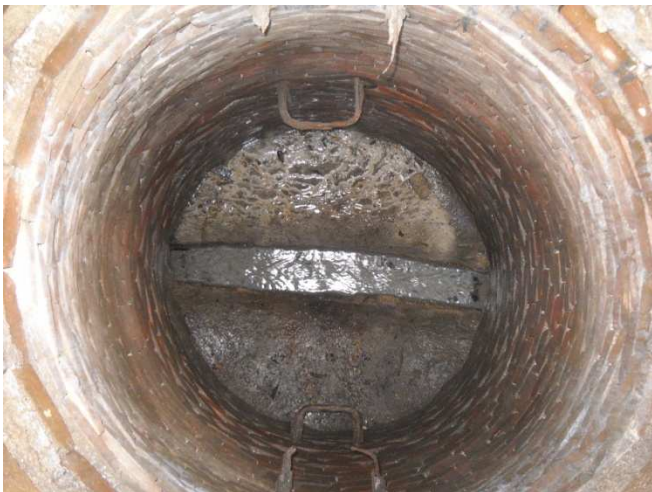
All of the inspected manholes within the village appeared to be in good structural condition with no fracturing/cracking of manhole walls, no missing brick, and no significant mortar deterioration. However, seven of the manholes had signs of I/I near the bottom ranging from mineral deposits to groundwater flowing through the wall of the manhole. See images below:

Manhole 510 – I/I at bottom of manhole with mineral deposits on north bench

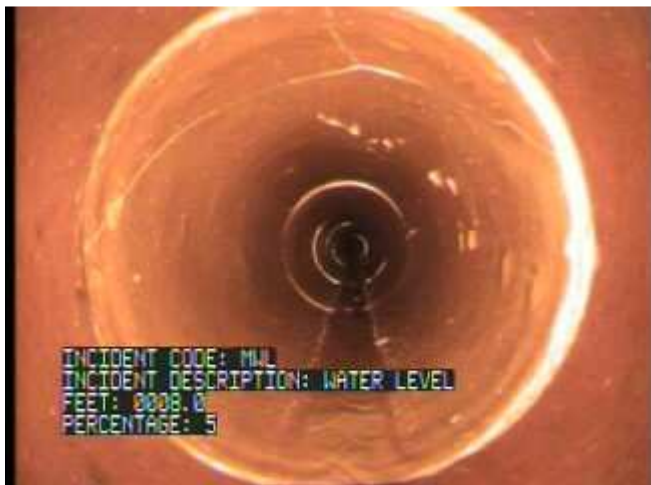
Crack Multiple @ 9.8' (Structural Grade 3)

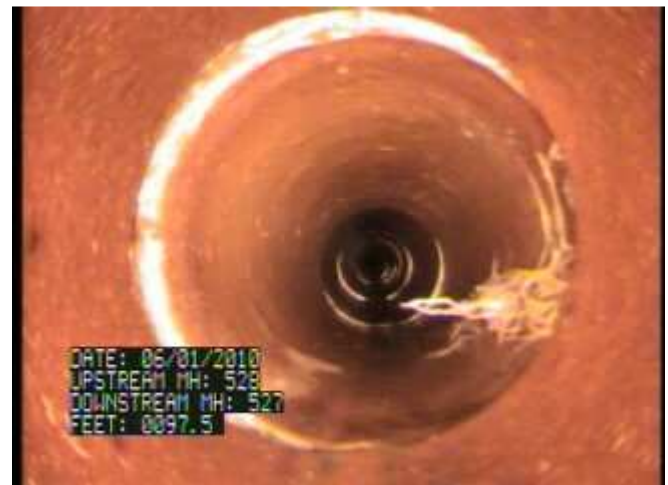
Fine Roots in Joint @ 98.7' (O&M Grade 1)

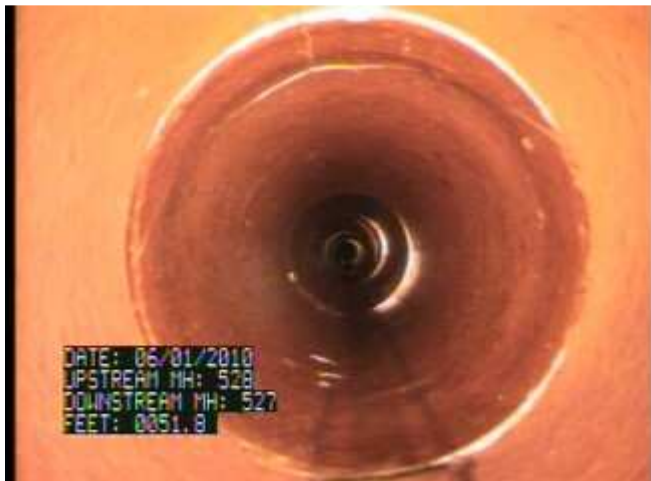
Crack Multiple @ 53.2' (Structural Grade 3)

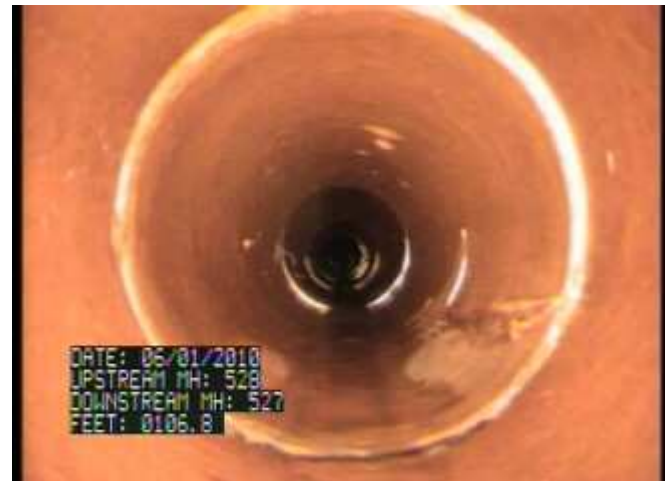
Fine Roots in Joint @ 108.3' (O&M Grade 1)

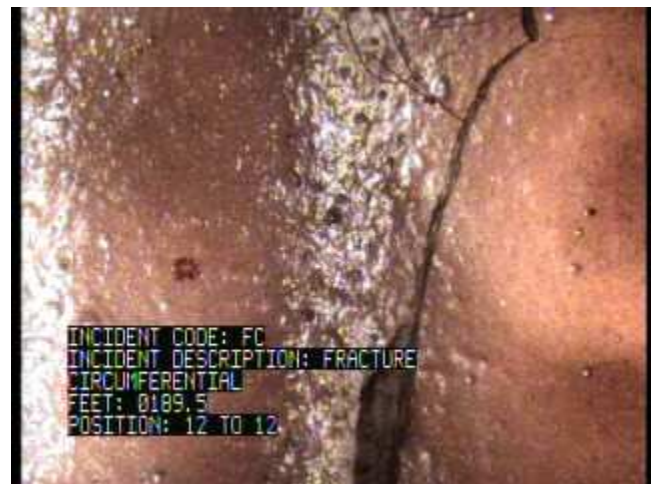
*Fracture Circumferential @ 189.5' (Structural Grade 2)
Fine Roots in Barrel of Pipe (O&M Grade 1)*

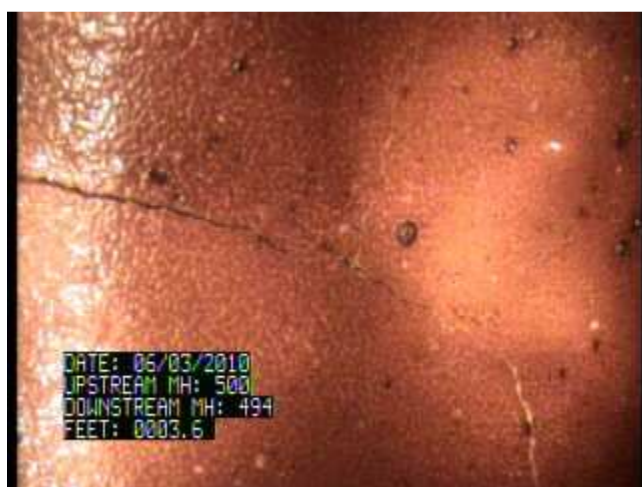
Crack Multiple @ 3.6' (Structural Grade 3)

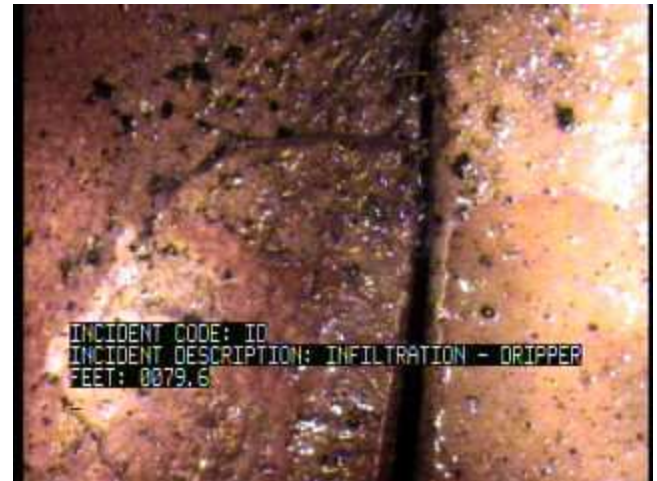
Infiltration Dripper @ 79.6' (O&M Grade 3)

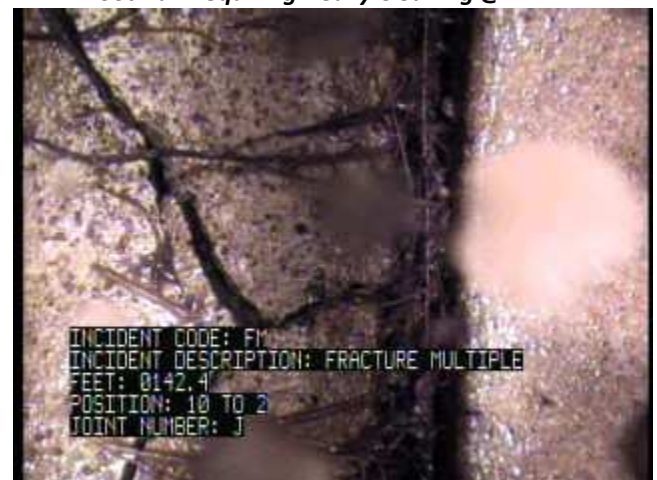
Fracture Multiple @ 142.4' (Structural Grade 4)

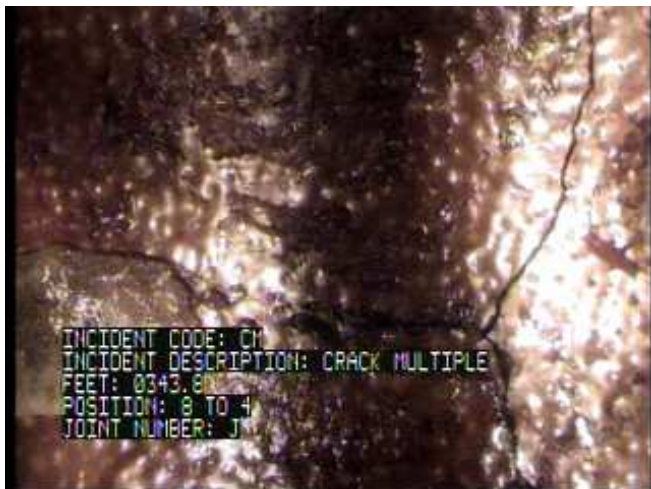
Crack Multiple @ 343.8 (Structural Grade 3)

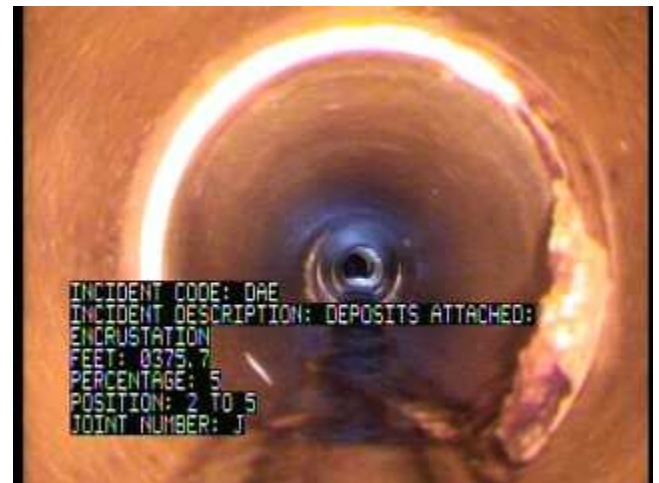
Mineral Deposits @ 375.7' (O&M Grade 2)

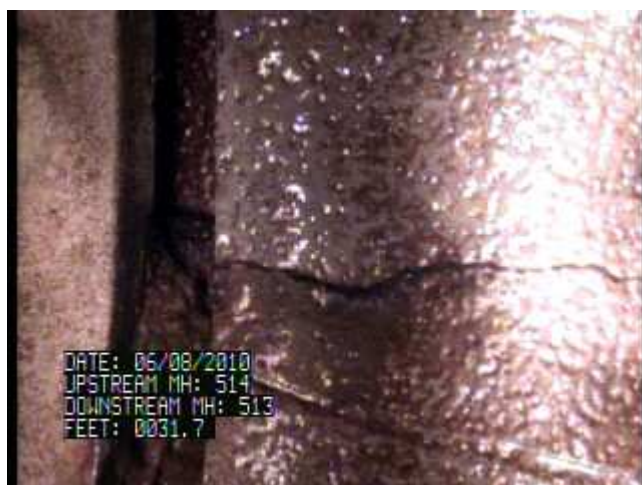
Crack Longitudinal @ 31.7' (Structural Grade 2)

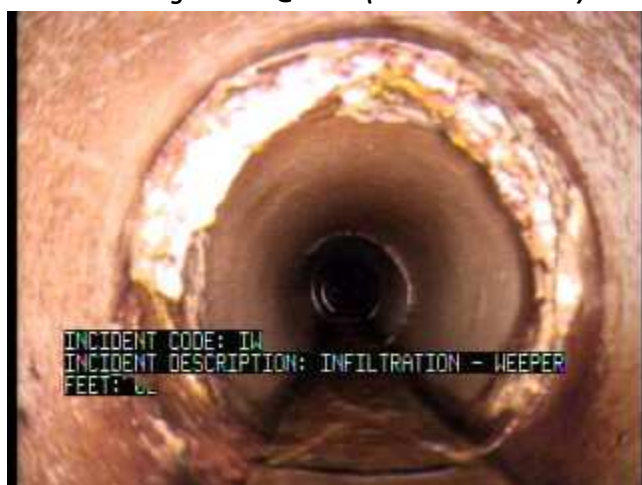
Infiltration Weeper @ 267.2' (O&M Grade 2)

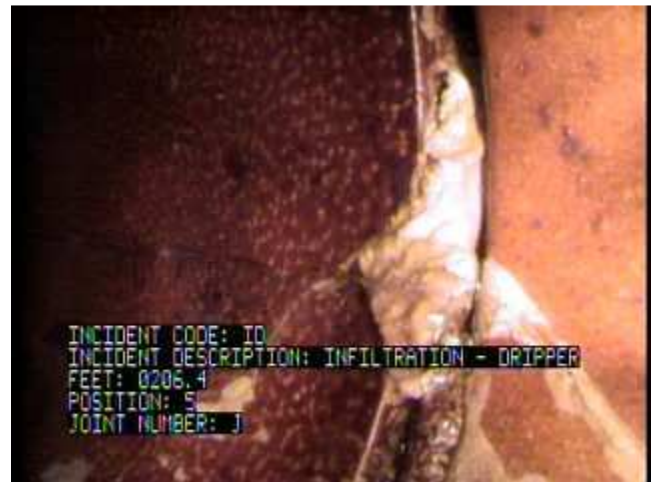
Infiltration Dripper @ 206.4' (O&M Grade 3)

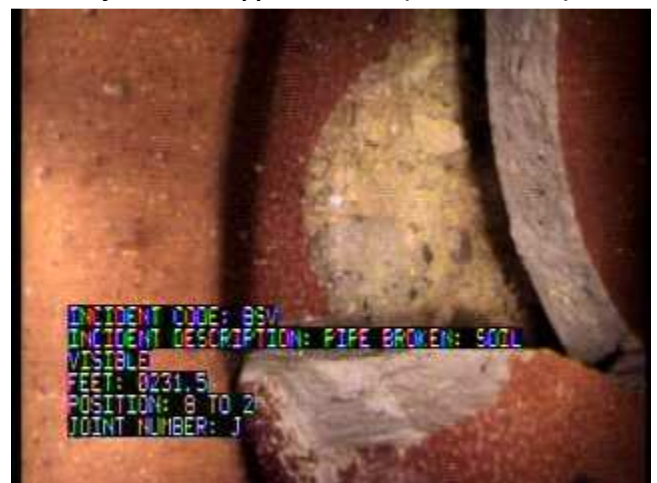
Broken Pipe w/ Soil Visible @ 231.5' (Structural Grade 5)

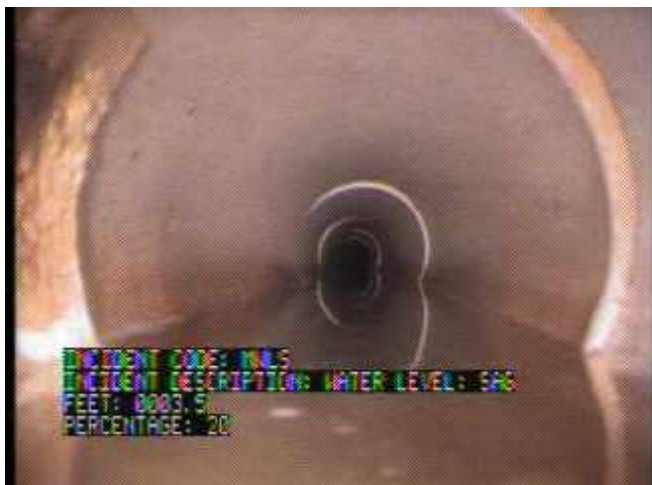
20% Sag @ 3.5' (O&M Grade 2)

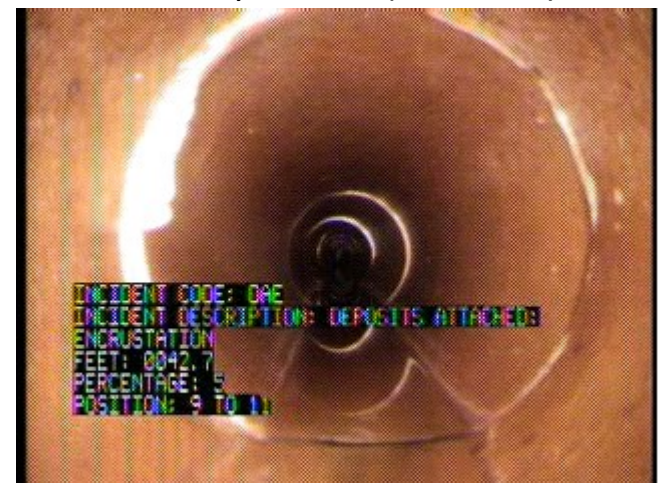
Mineral Deposit @ 42.7 (O&M Grade 2)

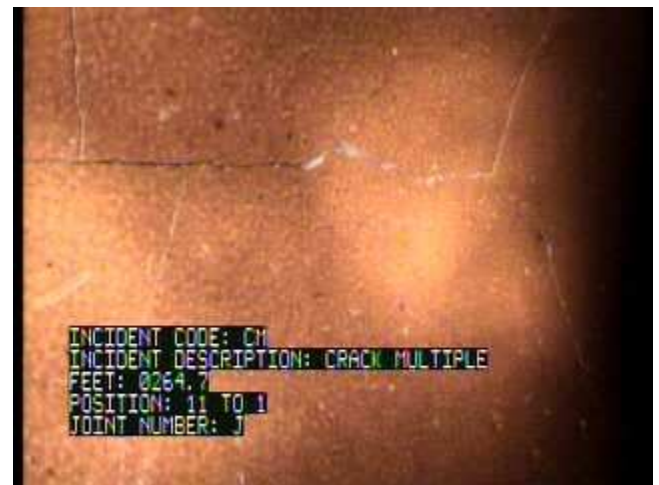
Crack Multiple @ 264.7' (Structural Grade 3)

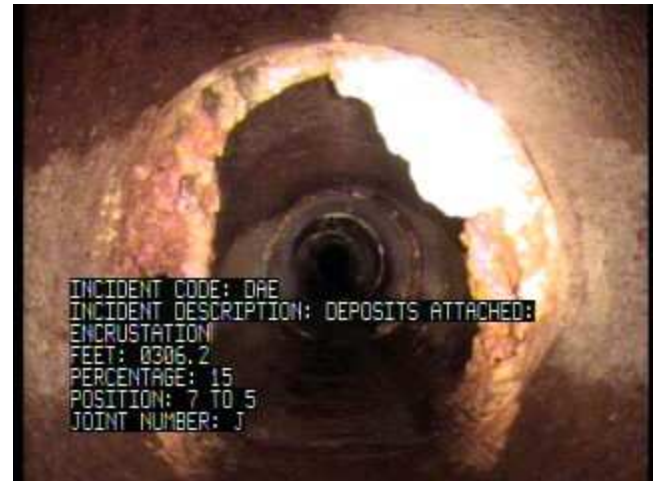
Mineral Deposit @ 306.2' (O&M Grade 3)

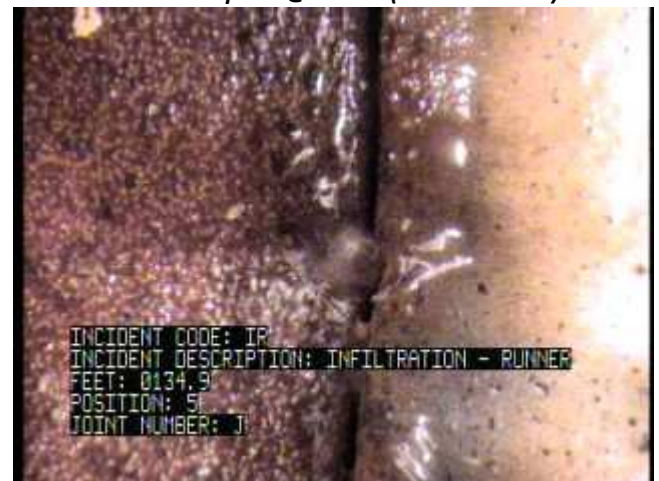
Infiltration Runner @ 134.9' (O&M Grade 4)

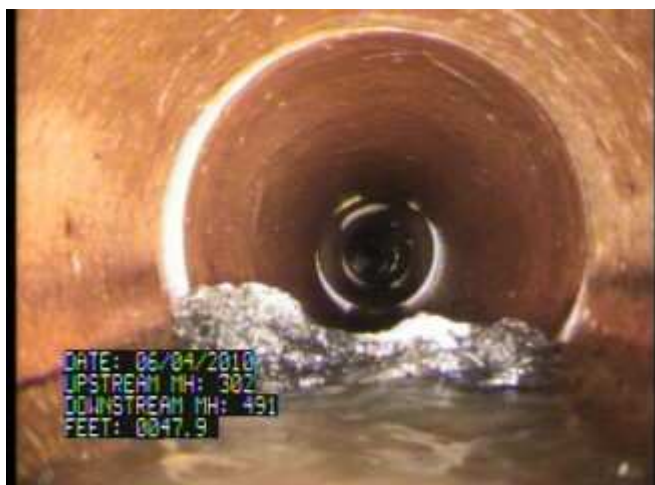
Intruding Sealing Material Requiring Heavy Cleaning @ 47.9'

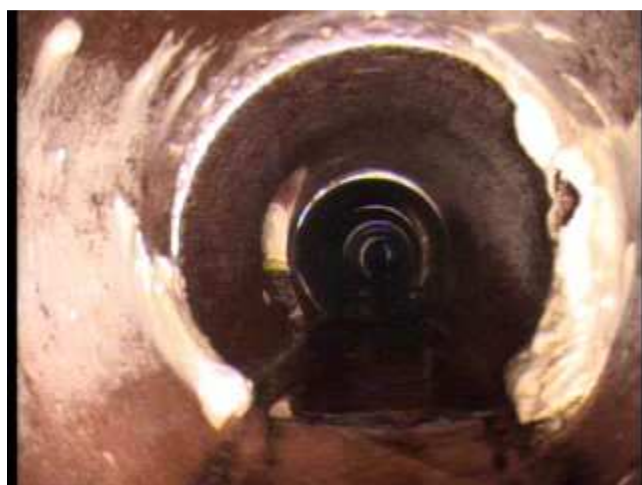
Mineral Deposit @ 27.5' (O&M Grade 2)

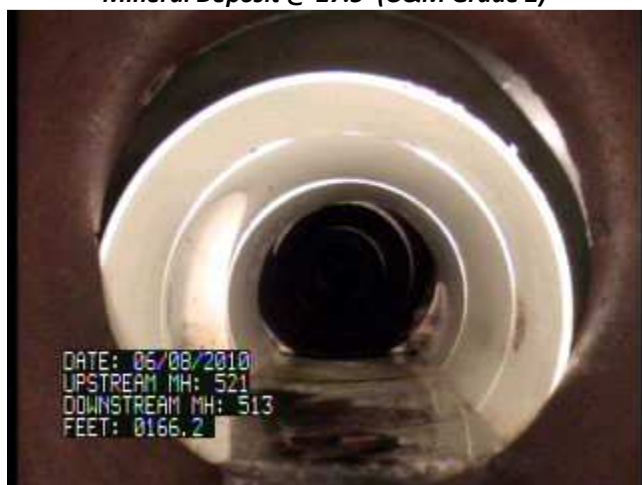
Large Offset joint @ 166.2' (O&M Grade 2)

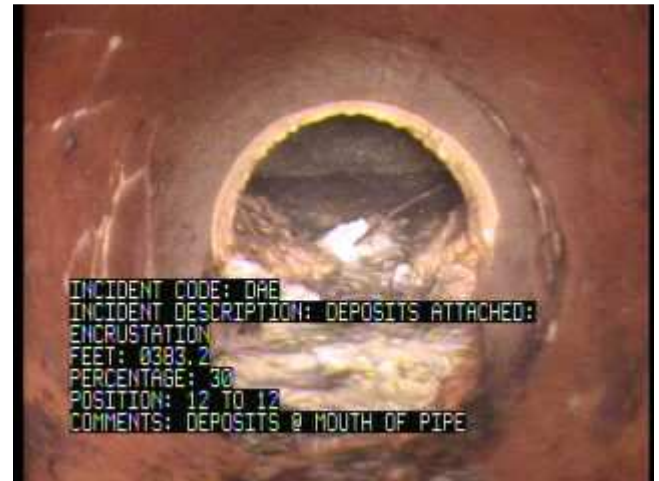
Mineral Deposits @ 383.2' (O&M Grade 4)

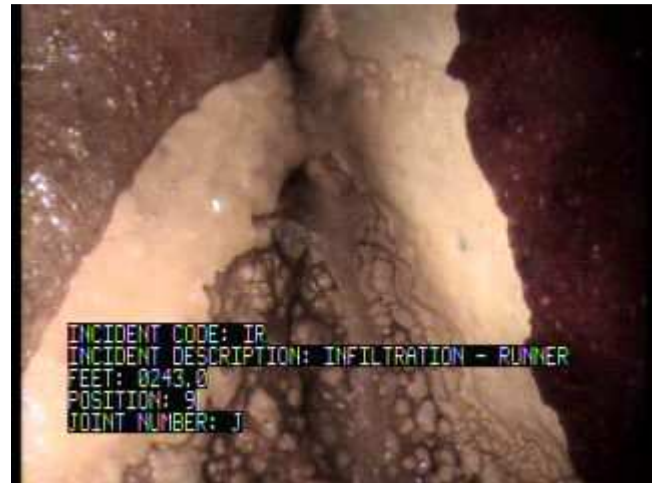
Infiltration Runner @ 243.0' (O&M Grade 4)

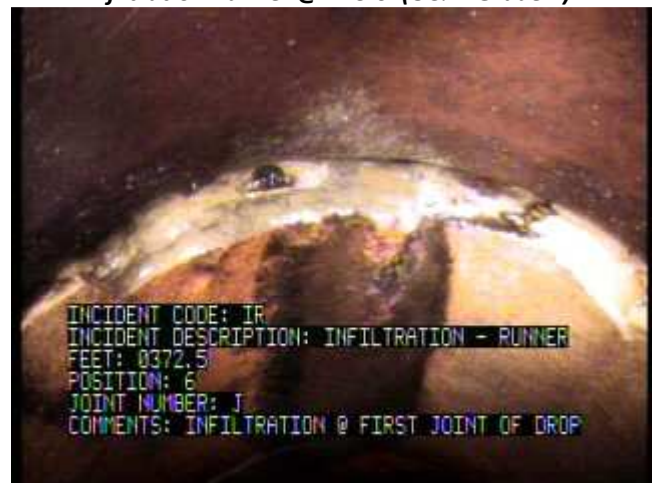
Infiltration Runner @ 372.5' (O&M Grade 4)

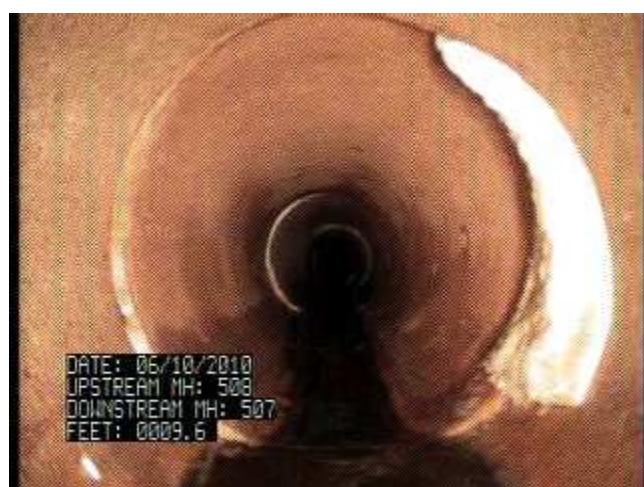
Mineral Deposit @ 9.6' (O&M Grade 2)

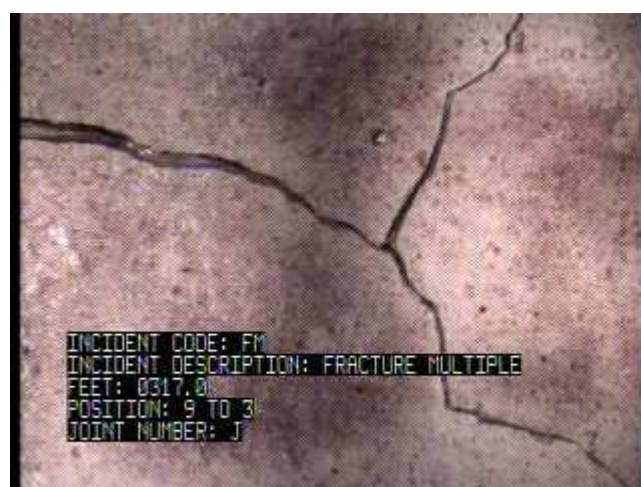
Fracture Multiple @ 317.0' (Structural Grade 4)

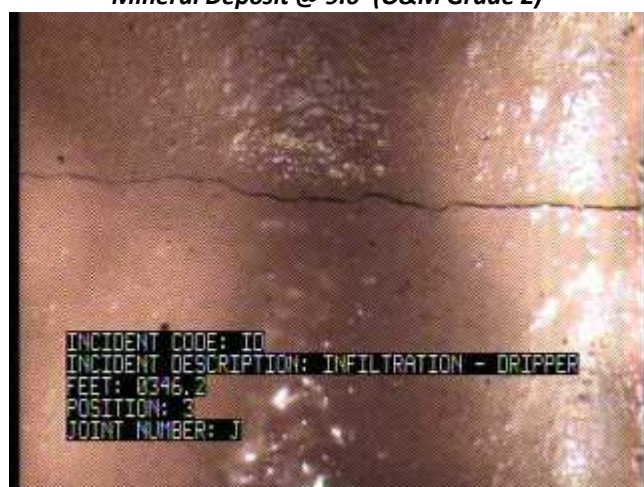
Infiltration Dripper @ 346.2' (O&M Grade 3)

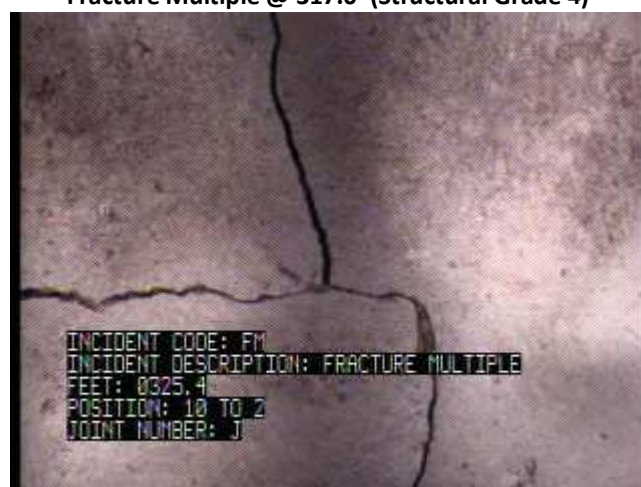
Fracture Multiple @ 325.4' (Structural Grade 4)

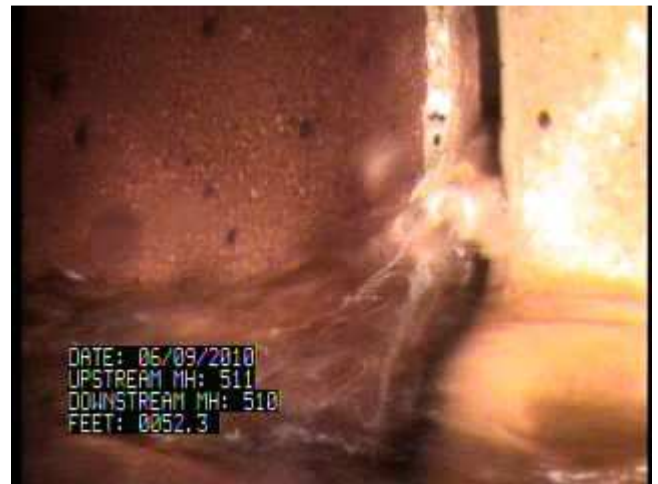
Infiltration Runner @ 52.3' – O&M Grade 4

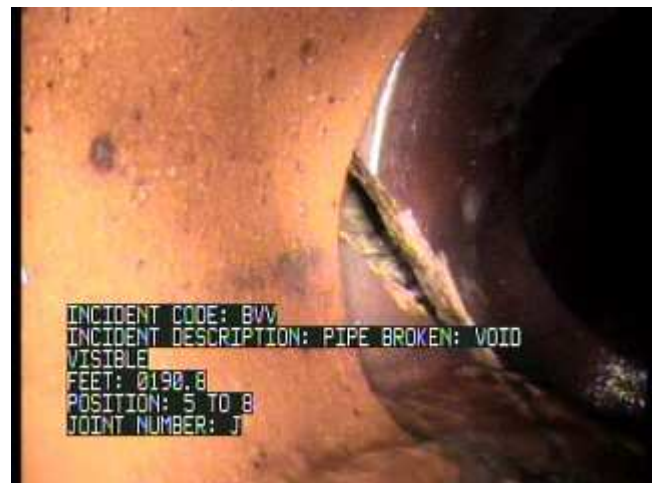
Broken Pipe w/ Void Visible @ 190.8' (Structural Grade 5)

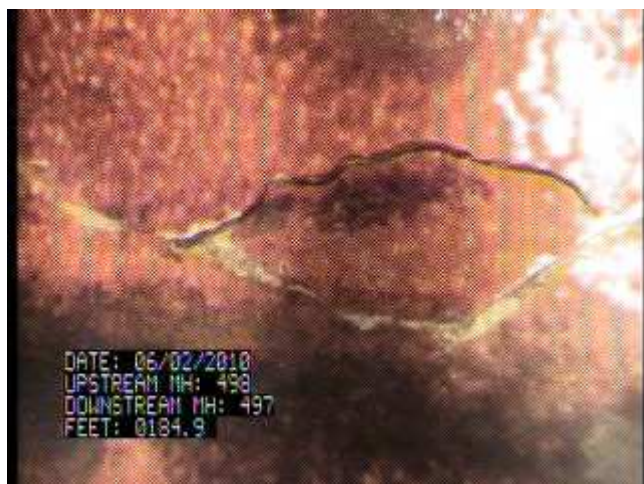
Fracture Multiple @ 184.9' (Structural Grade 4)

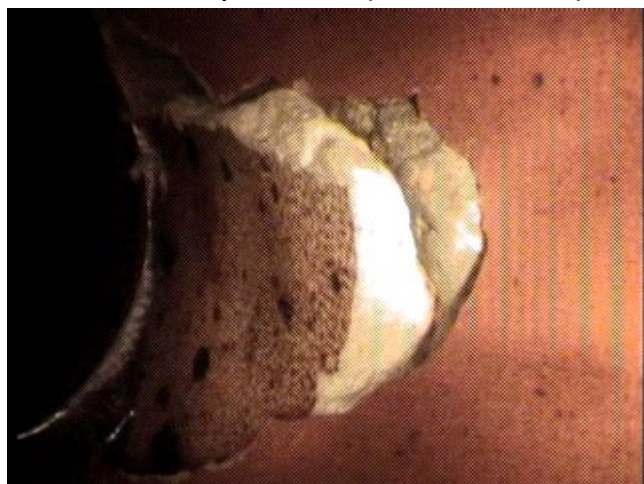
Broken Pipe @ 179.0' (Structural Grade 5)

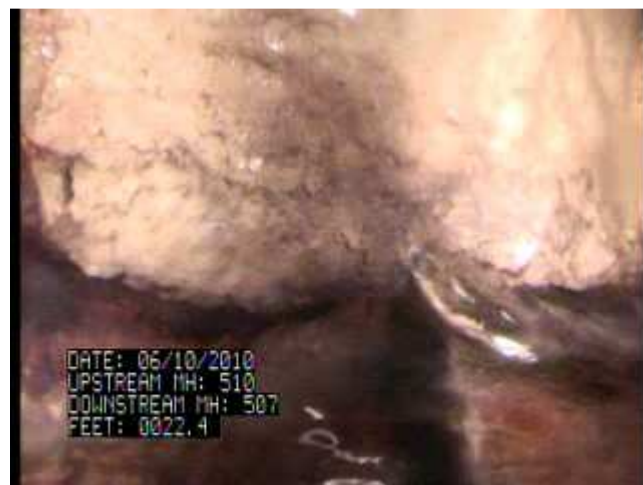
Infiltration Runner @ 22.4' – O&M Grade 4

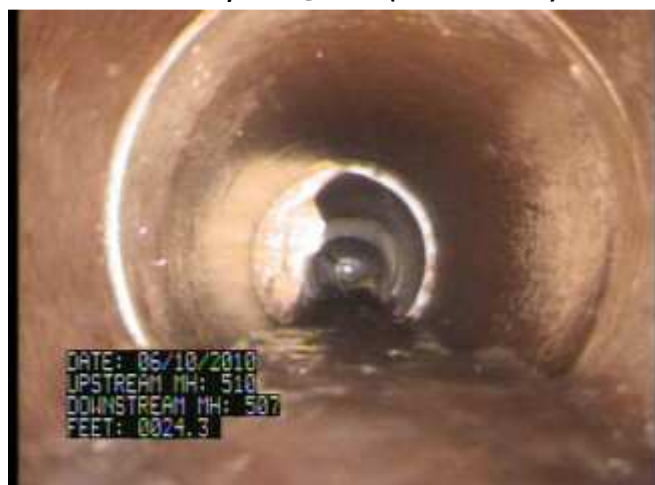
Mineral Deposit Requiring Heavy Cleaning @ 24.3'

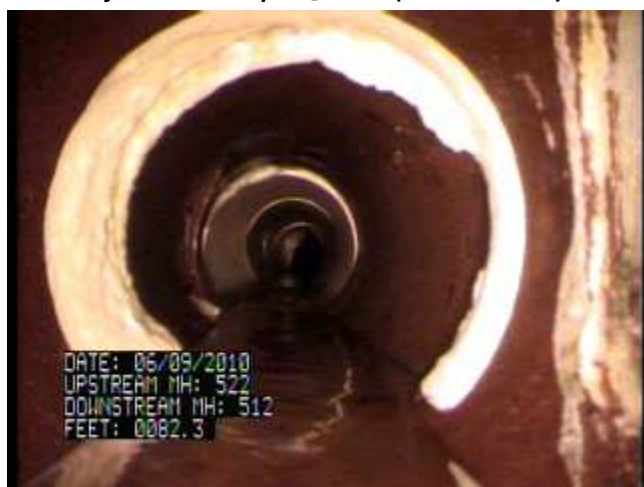
Mineral Deposits @ 82.3' (O&M Grade 3)

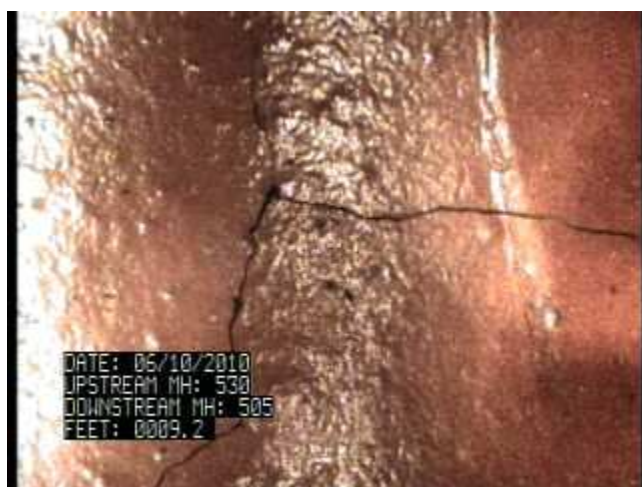
Crack Multiple @9.2' (Structural Grade 3)

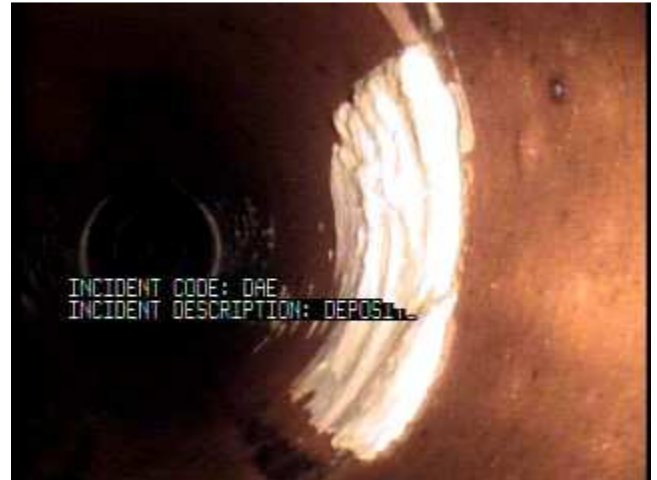
Mineral Deposit @ 312.6' (O&M Grade 2)

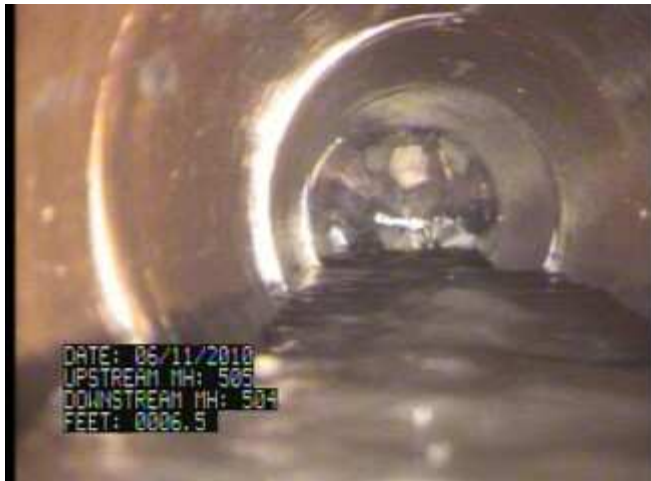
Root Ball in Joint Requiring Heavy Cleaning @ 6.5'

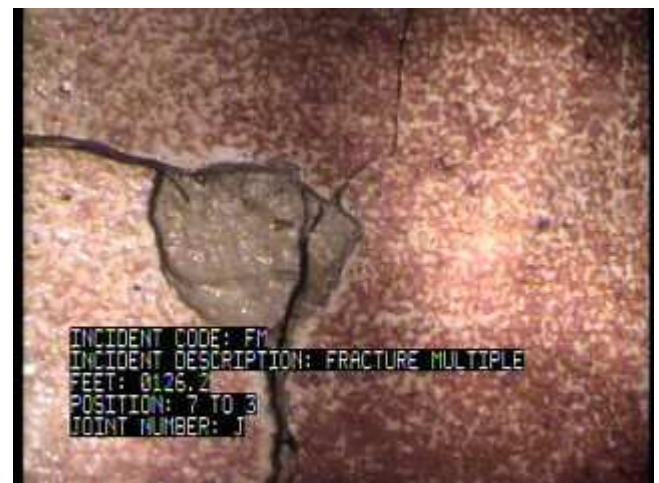
Fracture Multiple @ 126.2' (Structural Grade 4)

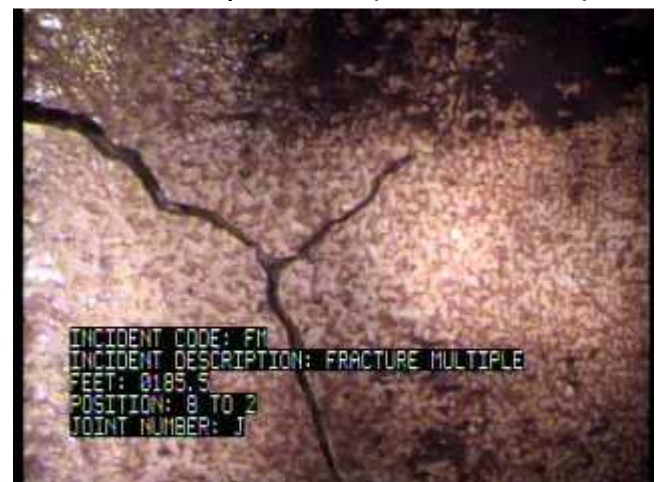
Fracture Multiple @ 185.5' (Structural Grade 4)

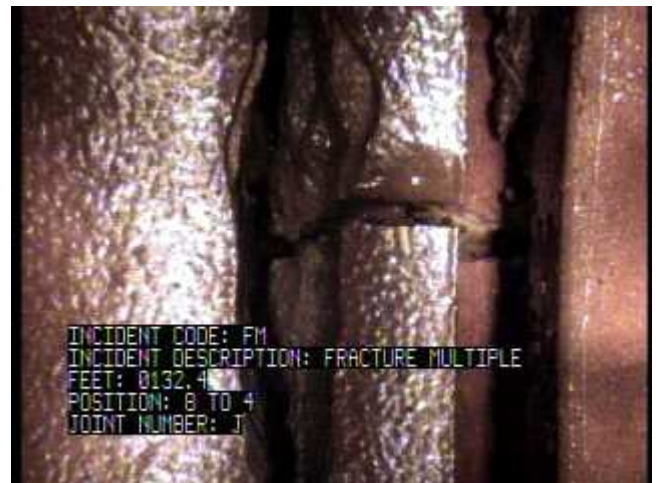
Fracture Multiple @ 132.4' (Structural Grade 4)

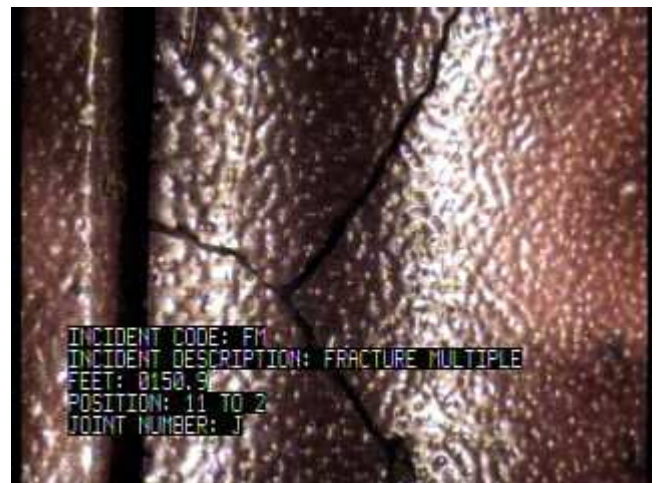
Fracture Multiple @ 150.9' (Structural Grade 4)

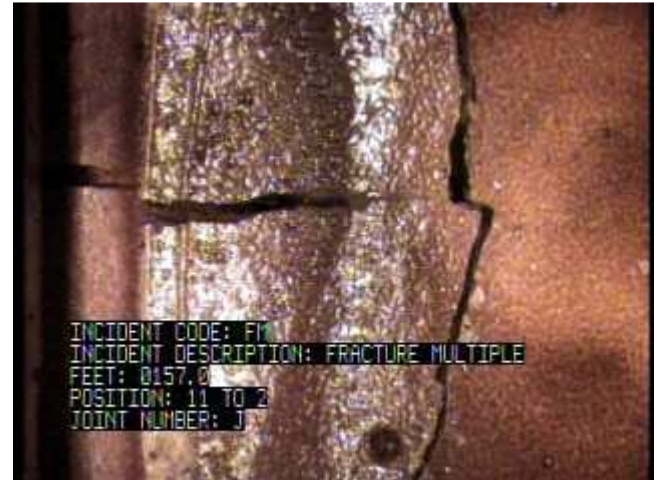
Fracture Multiple @ 157.0' (Structural Grade 4)

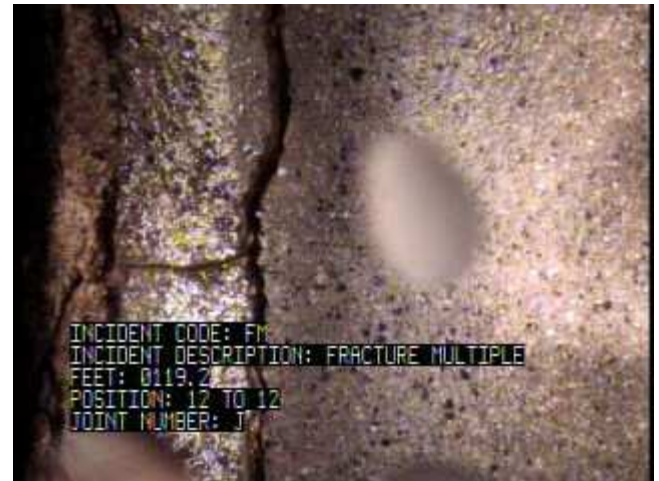
Fracture Multiple @ 119.2' (Structural Grade 4)

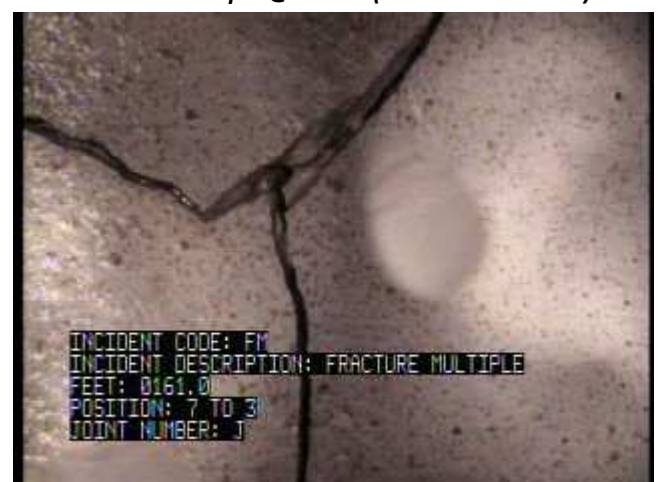
Fracture Multiple @ 161.0' (Structural Grade 4)

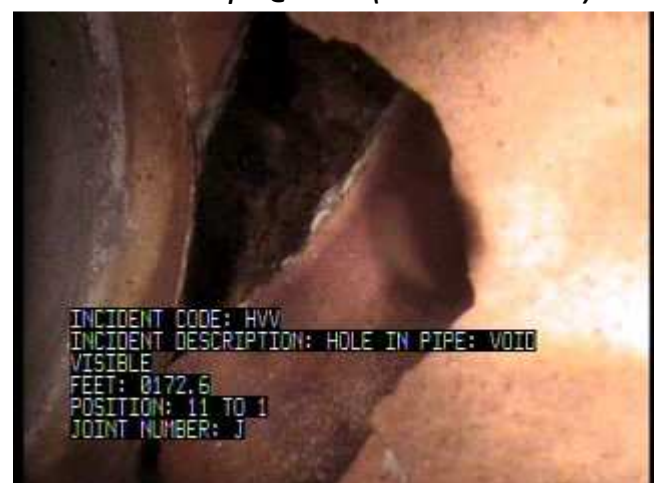
Hole in Pipe w/ Void Visible @ 172.6' (Structural Grade 5)

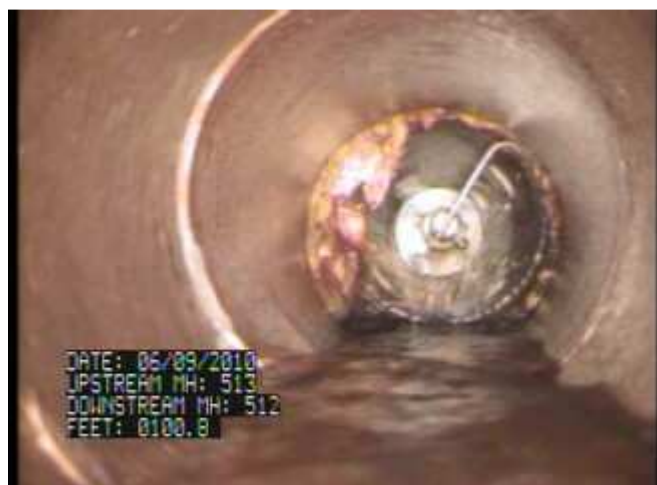
Mineral Deposit Requiring Heavy Cleaning @ 100.8'

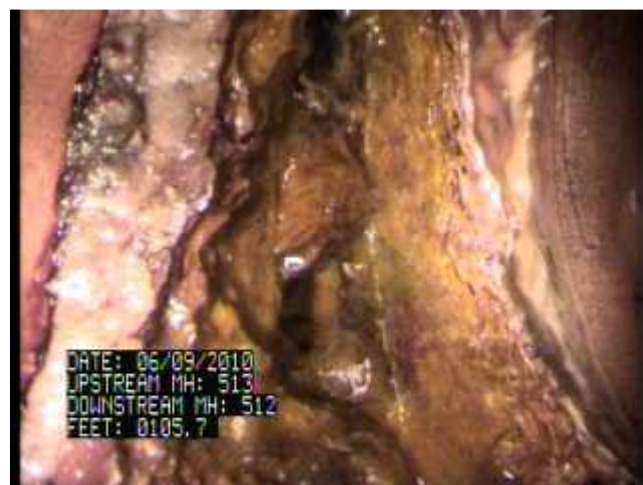
Infiltration Runner @ 105.7' (O&M Grade 4)

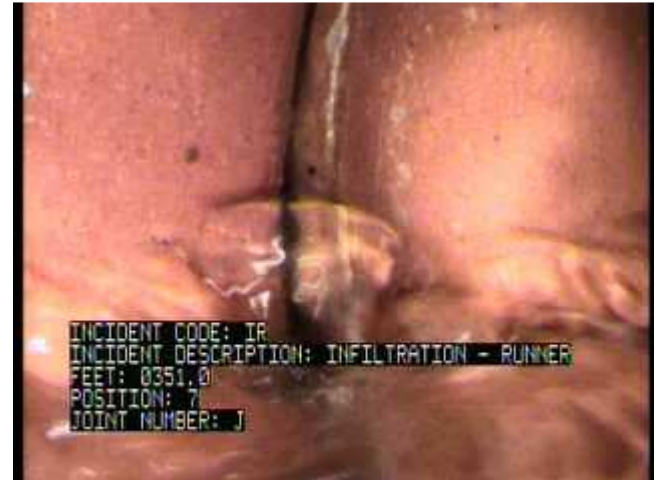
Infiltration Runner @ 351.0' (O&M Grade 4)

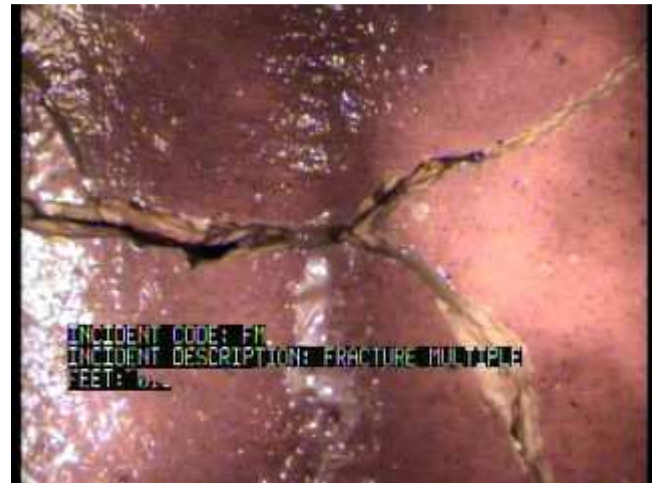
Fracture Multiple @ 182.1' (Structural Grade 4)

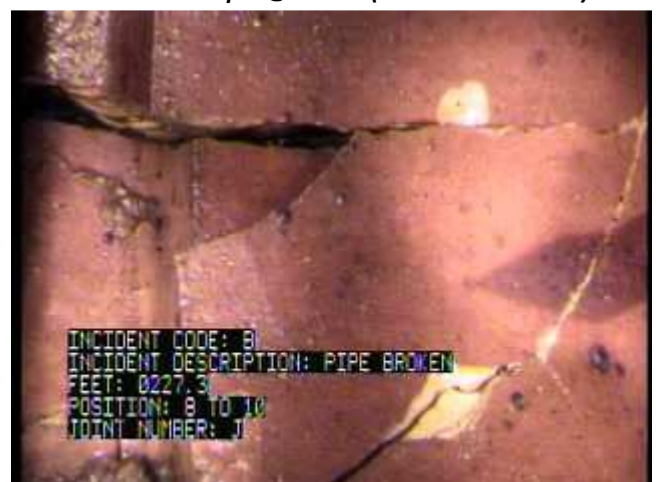
Broken Pipe @ 227.3' (Structural Grade 5)

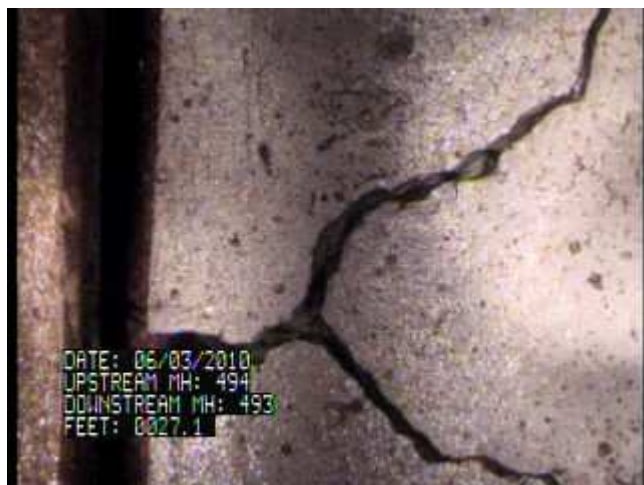
Fracture Multiple @ 27.1' (Structural Grade 4)

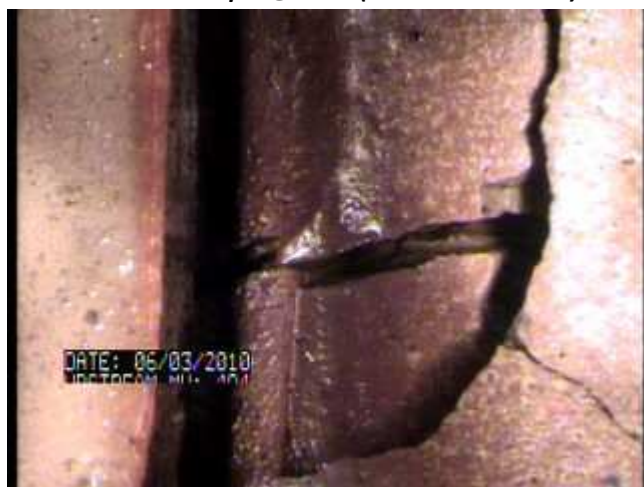
Broken Pipe @ 103.7' (Structural Grade 5)

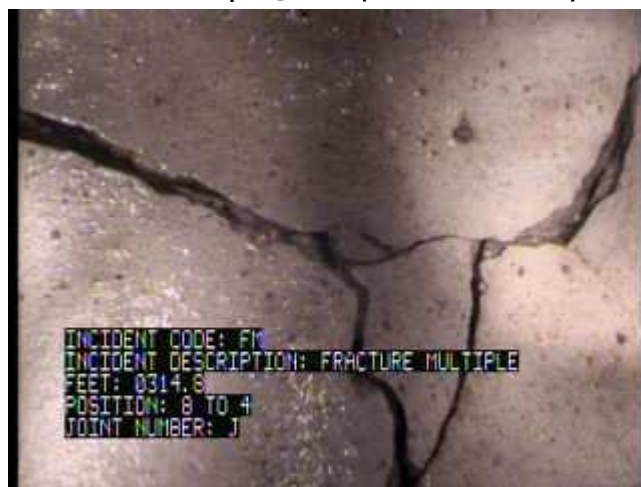
Fracture Multiple @ 314.8' (Structural Grade 4)

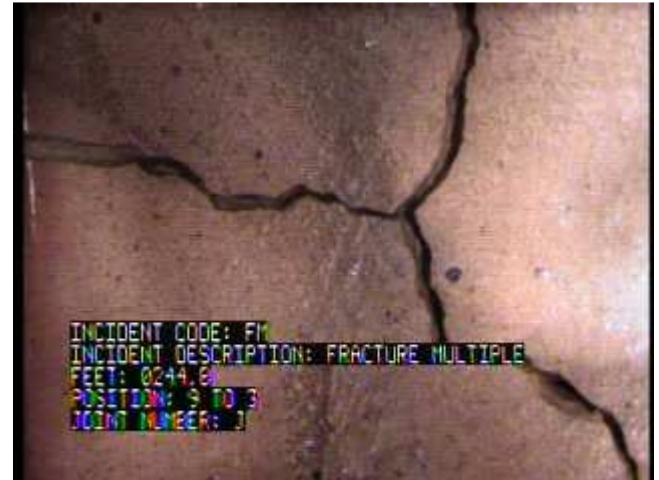
Fracture Multiple @ 244.6' (Structural Grade 4)

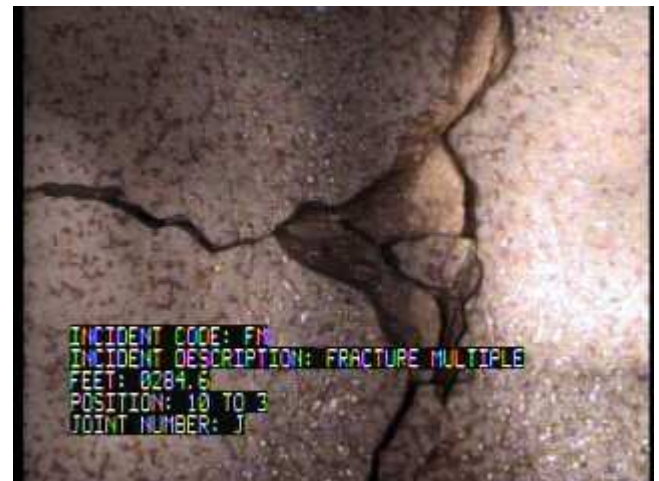
Fracture Multiple @ 284.6' (Structural Grade 4)

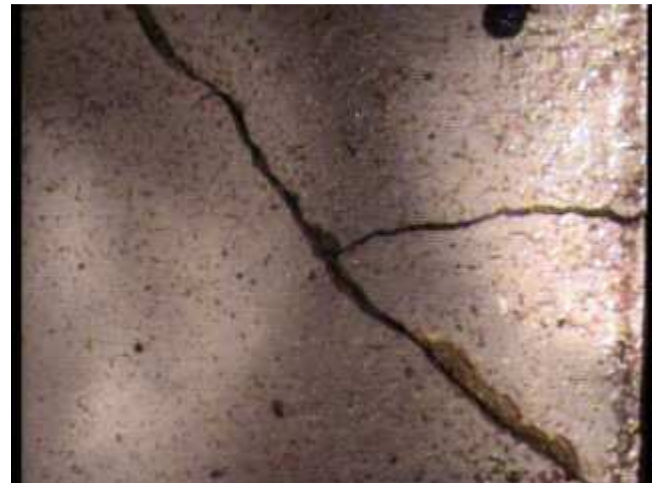
Fracture Multiple @ 102.6' (Structural Grade 4)

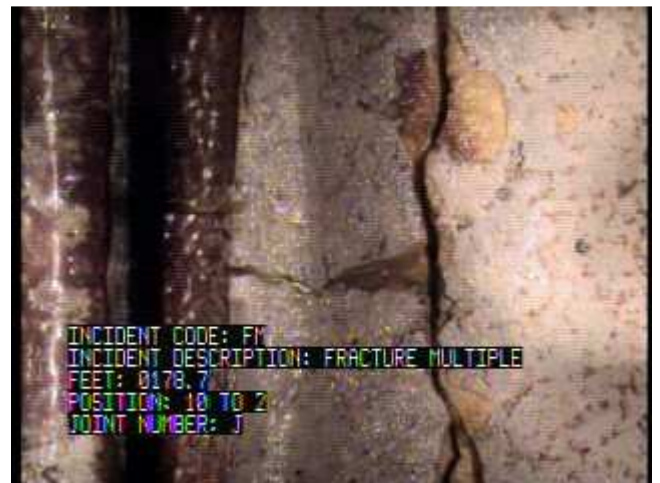
Fracture Multiple @ 178.7' (Structural Grade 4)

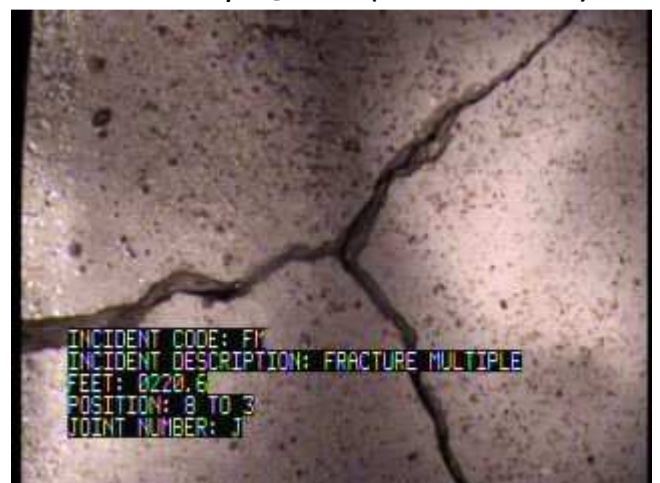
Fracture Multiple @ 220.6' (Structural Grade 4)

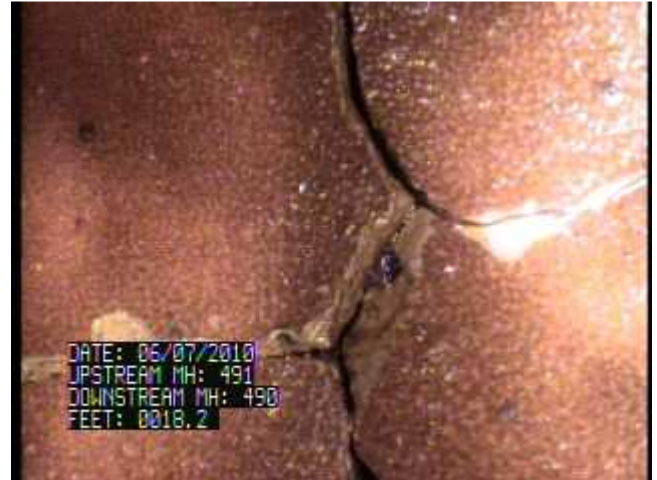
Fracture Multiple @ 18.2' (Structural Grade 4)

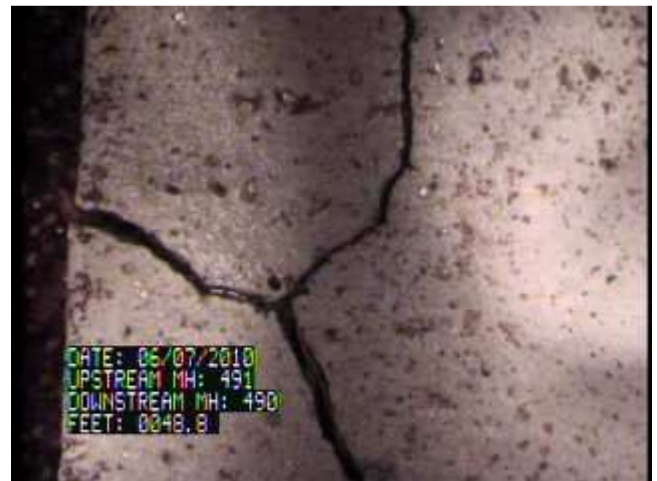
Fracture Multiple @ 48.8' (Structural Grade 4)

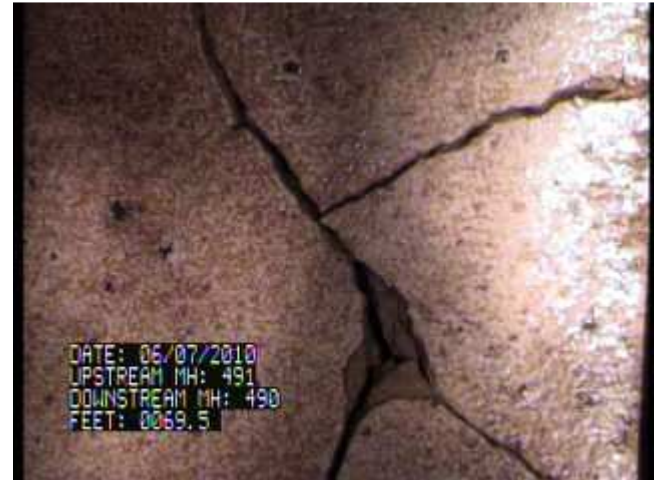
Fracture Multiple @ 69.5' (Structural Grade 4)

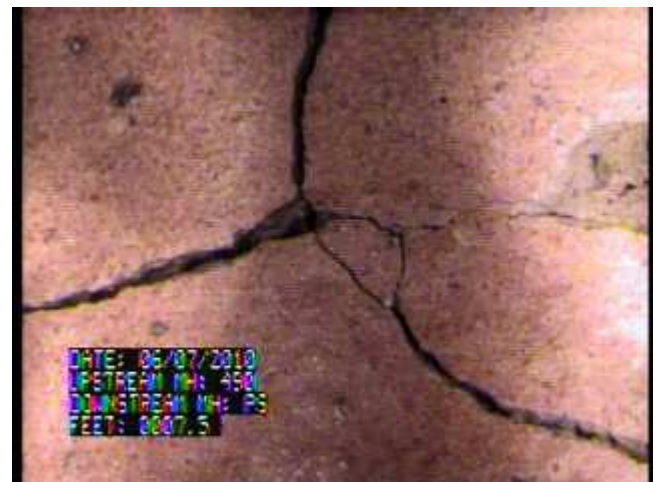
Fracture Multiple @ 7.5' (Structural Grade 4)

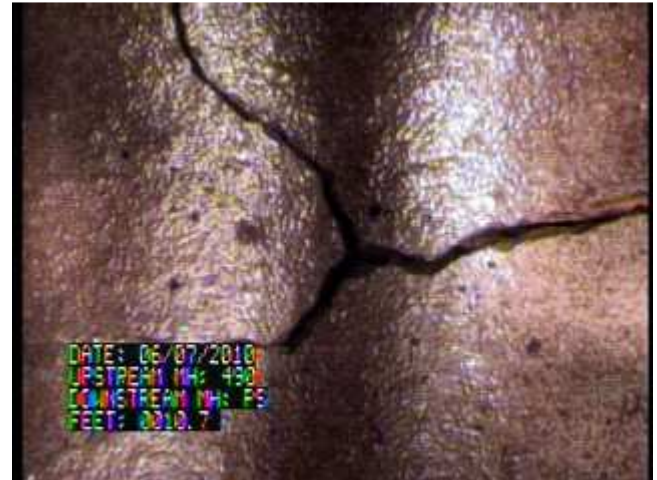
Fracture Multiple @ 10.7' (Structural Grade 4)

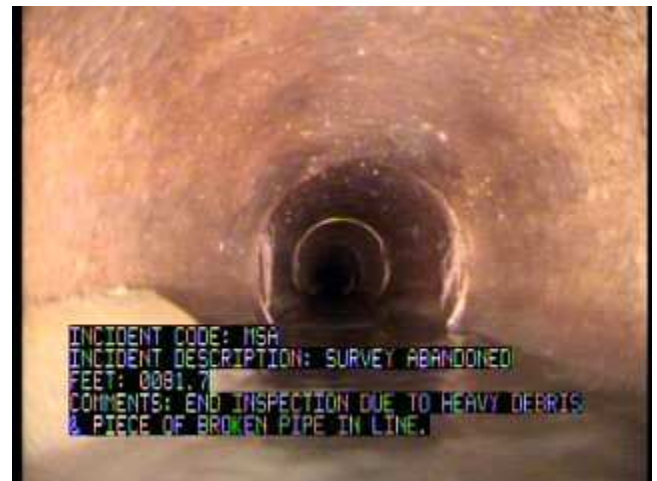
Debris in Pipe Causing End of Inspection @ 81.7'

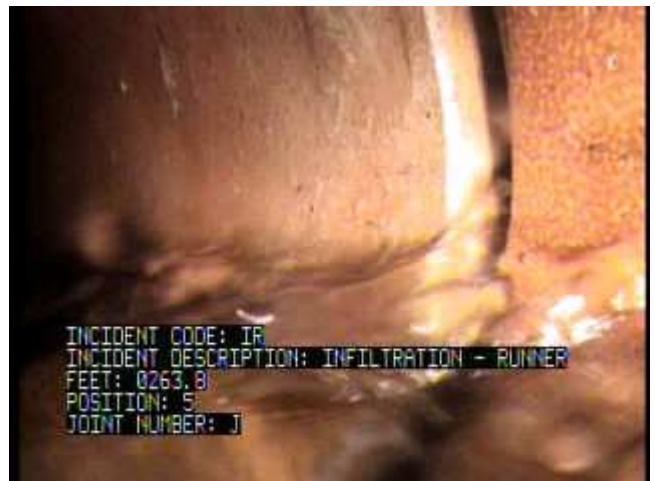
Infiltration Runner @ 263.8' (O&M Grade 4)

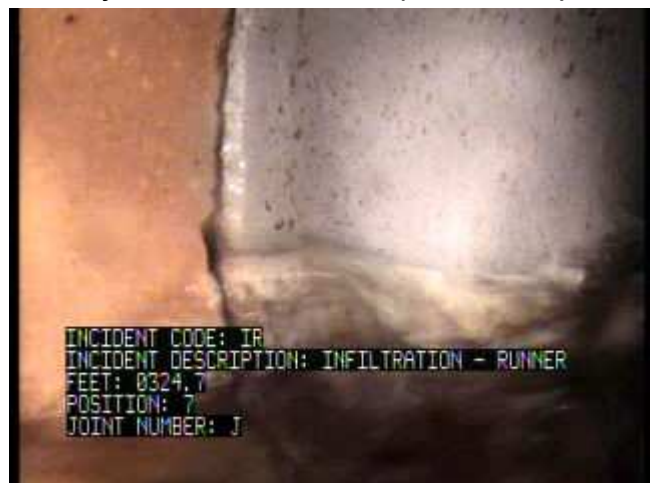
Infiltration Runner @ 324.7' (O&M Grade 4)
