BURGESS & NIPLE
Engineers ■ Architects ■ Planners

Sanitary Sewer System Evaluation Study

Riverlea, Ohio

January 2012

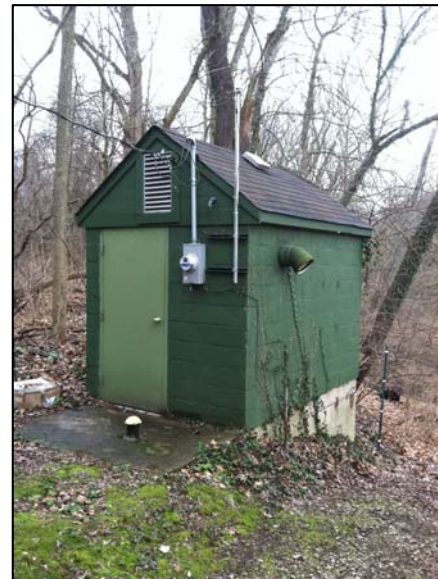
Figure 3-2 - Pump Station, Looking West

The duplex pumping station that receives the flow from the Olentangy Boulevard sewer is owned and operated by Riverlea. This station utilizes two submersible pumps operating at an average rate of 55 gpm each. A 4-inch cast iron force main carries the flow 650 feet to Manhole 504 located on the 10-inch Riverlea sewer running along the village's south corporation line. The pumping station receives flow from 36.8 of 93.8 total acres within the village (39%) which accounts for 47 of the 221 (21%) occupied homes. A high level overflow comprised of an 8-inch gravity sewer pipe connects the wet well to a storm sewer manhole located just west of the station. The manhole is part of an 18-inch gravity storm sewer that outlets directly into the Olentangy River at the southwest corner of the village.

The pump station is monitored 24 hours a day by an electronic telemetry and alarm system. This system alerts the designated first responders via telephone of any pump failures and/or high level alarms. The system also records pump operational data which is used to better manage station operation and track flow volume. Detailed information on station characteristics, operation, maintenance, and the alarm system is included under Tab 3.

The Riverlea collection system is divided into three catchments or subareas. The first and smallest of these subareas includes approximately 12.2 acres of property located along Riverglen Drive east of Falmouth Court. The 8-inch Riverglen sewer serving this subarea discharges into the 15-inch Worthington sewer at Falmouth Court. The second and largest subarea, comprising approximately 44.8 acres, is tributary to the sewers located along Southington Avenue and Dover Court. This subarea discharges through a 10-inch sewer at the southeast corner of the village into the 15-inch Worthington sewer. The third subarea includes approximately 36.8 acres of property tributary to the 8-inch Olentangy Boulevard sewer and discharges into the pumping station located at the southwest corner of the village (*Figure 3-2*).

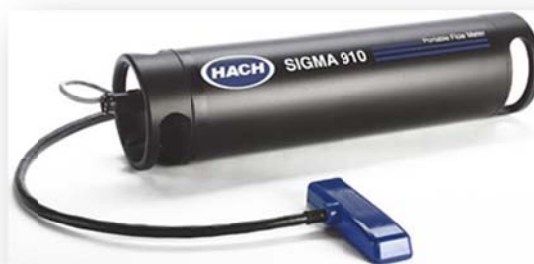
Figure 5-2 – Hach Sigma 910 Flowmeter

Flowmeter, rain gauge, and ground-water gauge installations were completed by a two-person crew from B&N on April 6 and 7, 2011. The flowmeters were set up to record flow in gallons per minute (GPM) at five-minute intervals, velocity in feet per second (FPS), and depth in inches. *Figure 5-2* shows the Hach Sigma 910 model used at each metering site. These flowmeters measure fluid depth using a combination pressure transducer and velocity sensor placed at the invert of the incoming sewer line. The velocity sensor uses Doppler waves to measure the velocity of suspended solids in the flow stream. The diagram in *Figure 5-3* illustrates a typical Sigma 910 flowmeter installation.

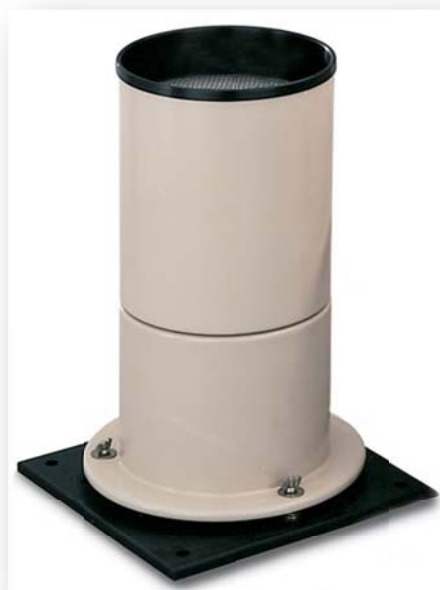
Figure 5-5 – Typical Rain Gauge

Figure 5-5 shows the rain gauge model used on this project. As with the flowmeters, weekly downloading of the rain gauge to a laptop computer was performed to reduce the possibility of data loss and ensure accurate operation.

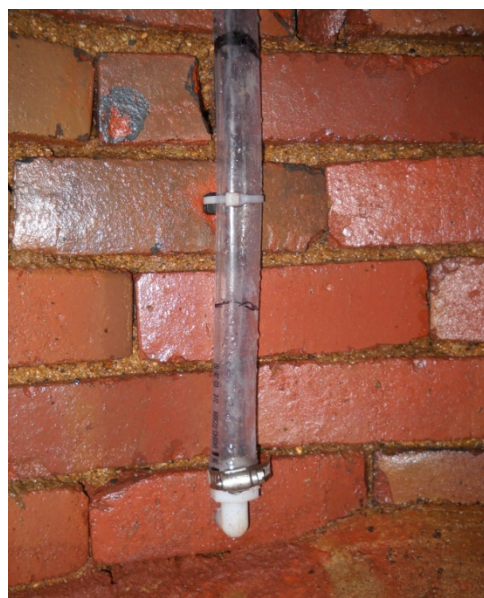
Figure 5-6 – Typical Ground Water Gauge

Ground water gauges (sight glasses) were installed in MH 490 and MH 524 to establish ground water levels at the upper and lower ends of the collection system. Each gauge was placed low in the manhole near the bench by drilling completely through the manhole wall and fitting the hole with a ¼" watertight, nylon "barb." Plastic transparent tubing was attached to the nylon fitting and secured to the manhole wall extending upward towards the top of the manhole. The tubing was marked at one-foot intervals, and the water level observed and recorded on a weekly basis.

During April and May between 1 and 4 inches of ground water was recorded at MH 524, indicating that the water table elevation was high enough for ground water to enter the sanitary collection system through cracks in the pipe, poorly sealed joints, and leaky manholes. However, during June and July the gauge was dry, suggesting that the water table had receded below the sanitary collection system.

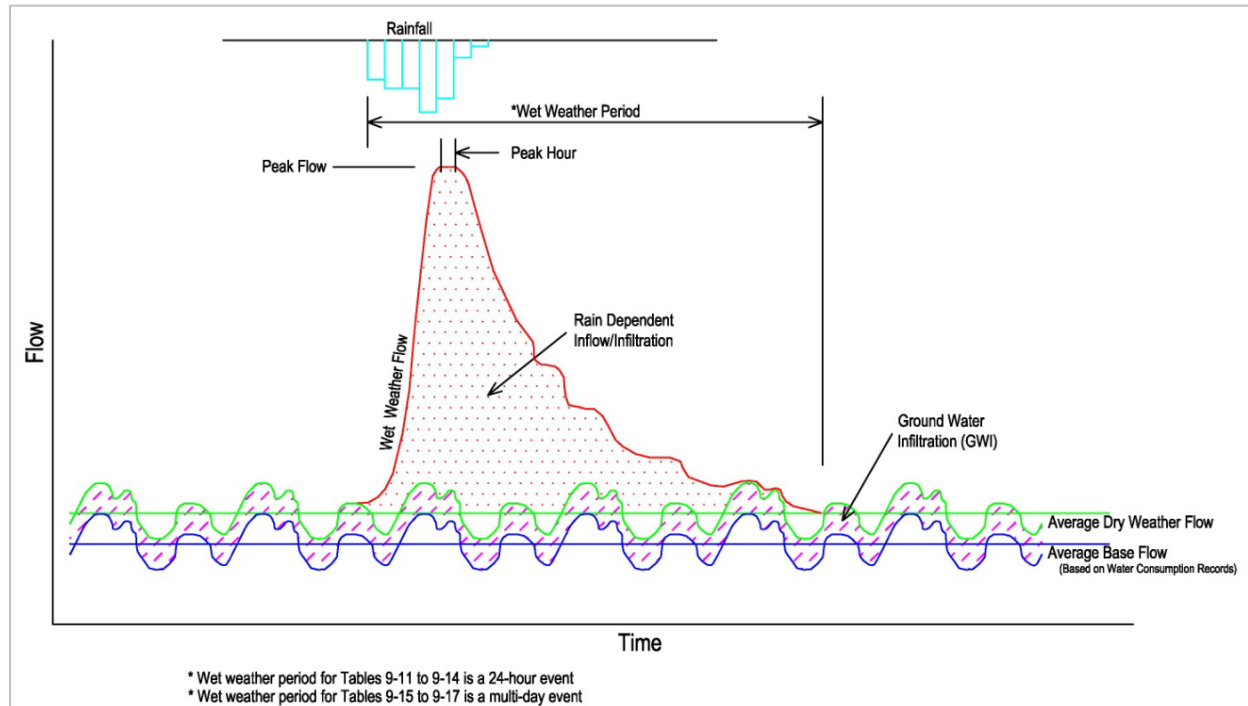
Figure 5-7 – Typical Wet-Weather Hydrograph

metering period, all of the collected data was analyzed to determine representative dry-weather and wet-weather flows. Following are details of the process used for determination of these flows. *Figure 5-7* shows a graphical representation of the sanitary sewer flow components of a typical hydrograph. The actual hydrographs for each metering location are included in *Appendix C and D*.
