Appendix B

Project Objective

Village of Riverlea, Ohio

Sanitary Sewer Evaluation Study

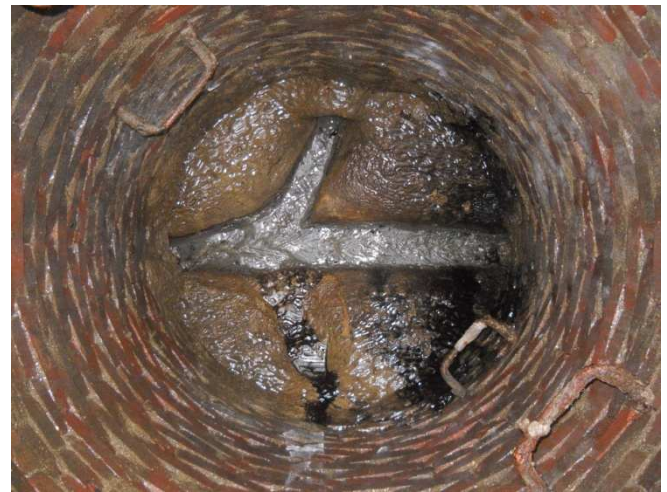
Manhole 513 - I/I at bottom of manhole with mineral deposits on the bench

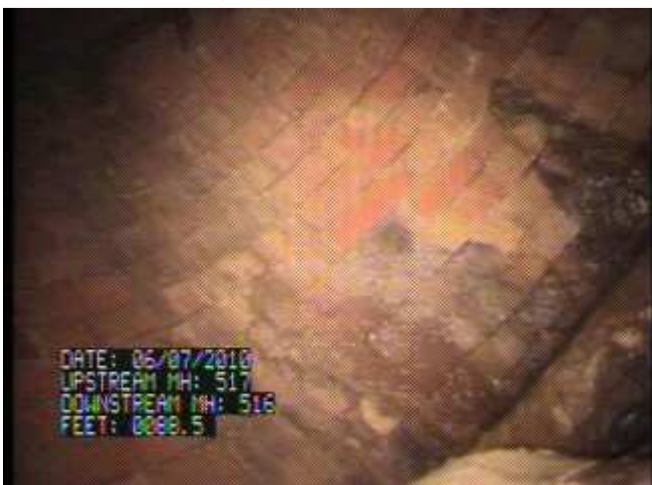
Manhole 517 – Slight I/I through walls at bottom of manhole

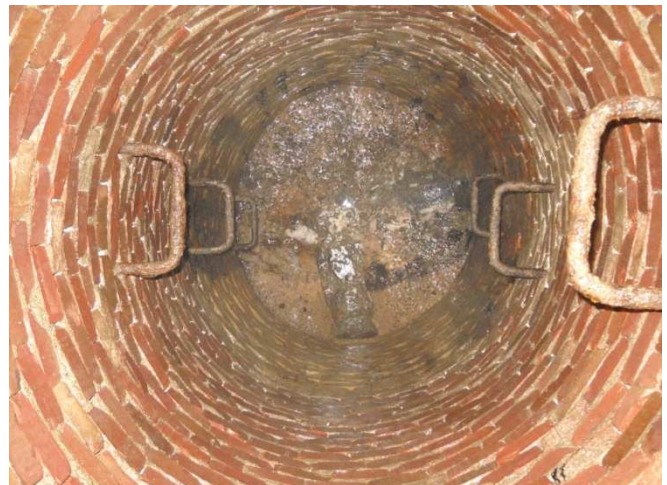
MH 520 – I/I through walls towards bottom of manhole with mineral deposits

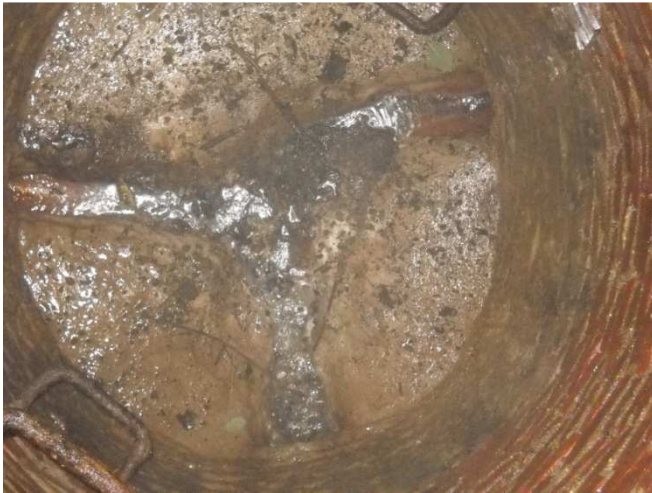
***MH 521 – I/I through walls towards bottom of manhole
with mineral deposits***

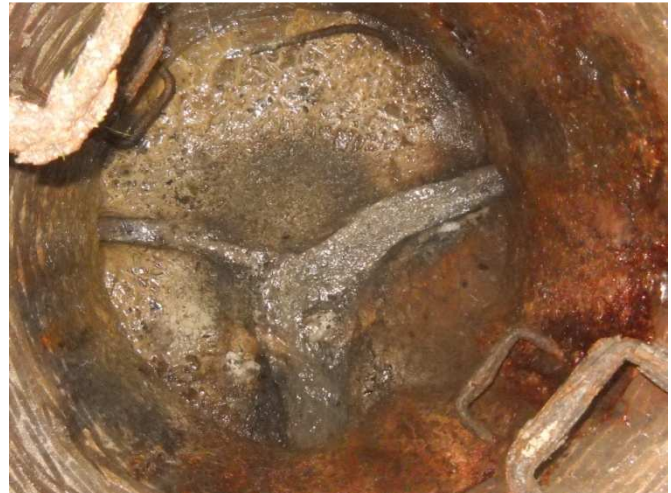
***MH 522 – I/I through walls towards bottom of manhole
with mineral deposits***

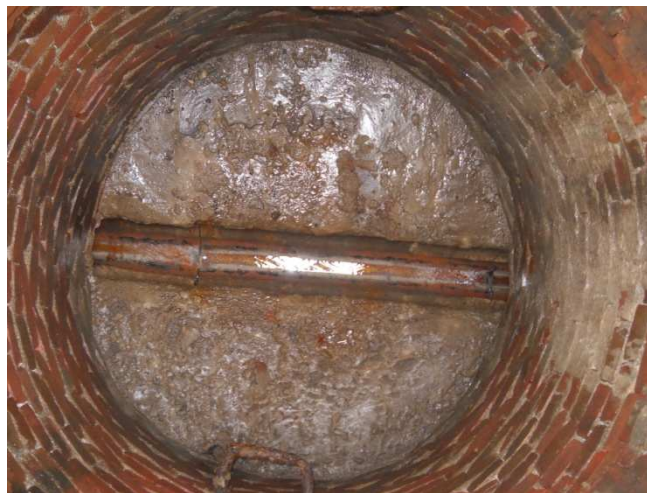
MH 527 – I/I through walls towards bottom of manhole with mineral deposits

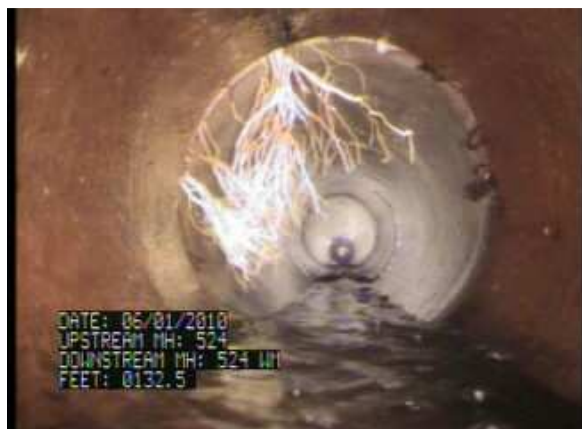
Fine Roots in Joint @ 132.5' (O&M Grade 1)

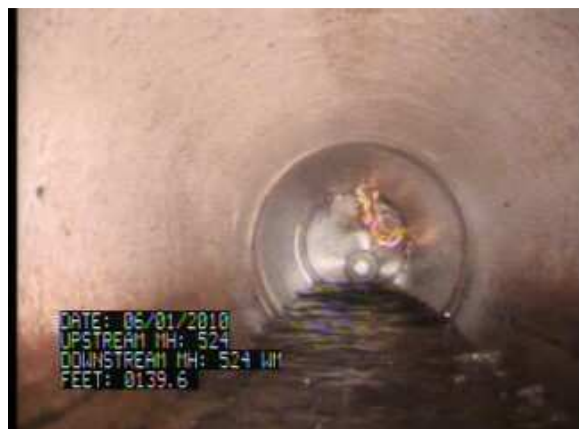
Medium Roots in Joint @ 142.8' (O&M Grade 2)

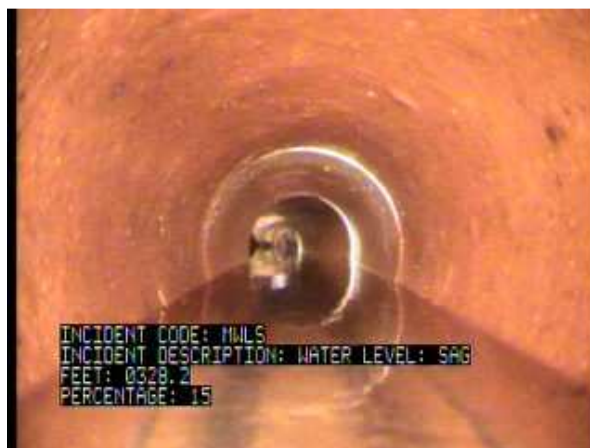
15% Sag @ 328.2' (O&M Grade 2)

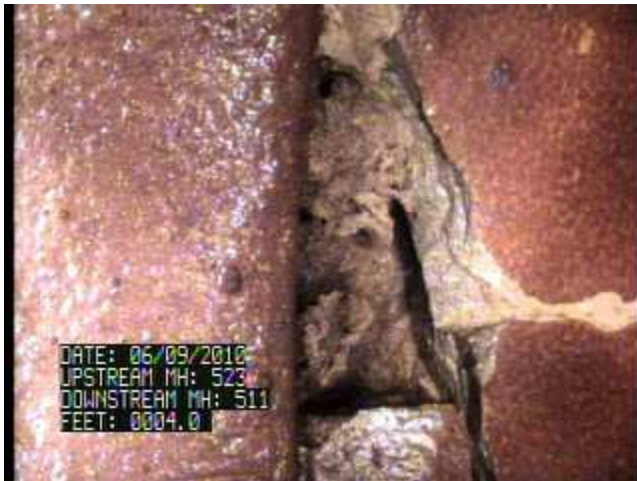
Broken Pipe @ 4.0' (Structural Grade 5)

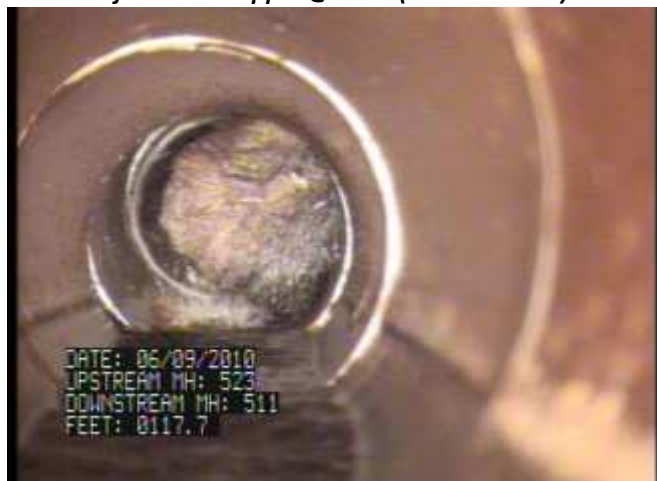
Root Ball Requiring Heavy Cleaning @ 117.7'

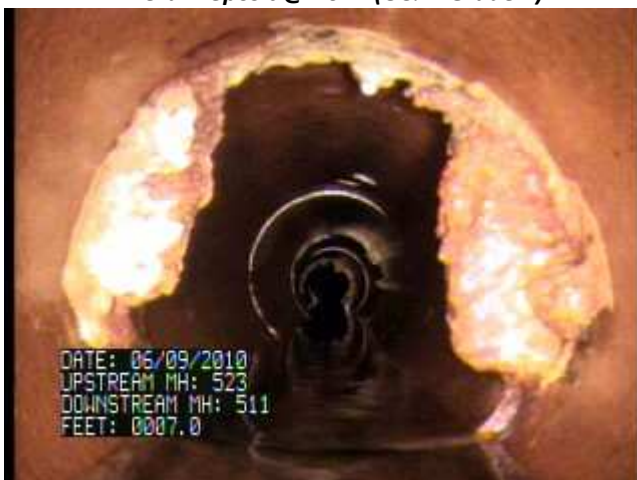
Mineral Deposit @ 7.0' (O&M Grade 4)

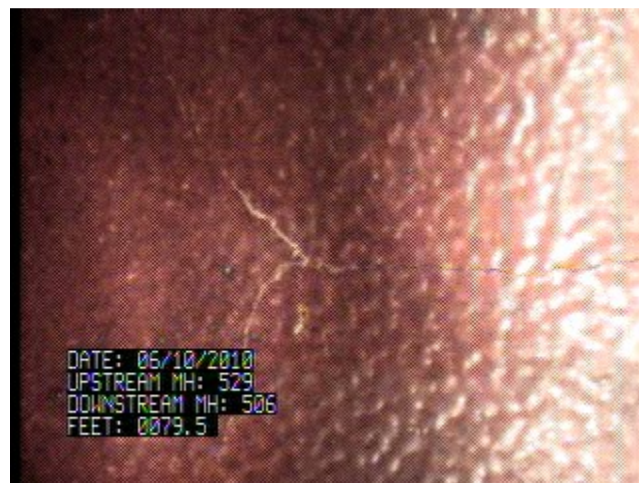
Crack Multiple @ 79.5' (Structural Grade 3)

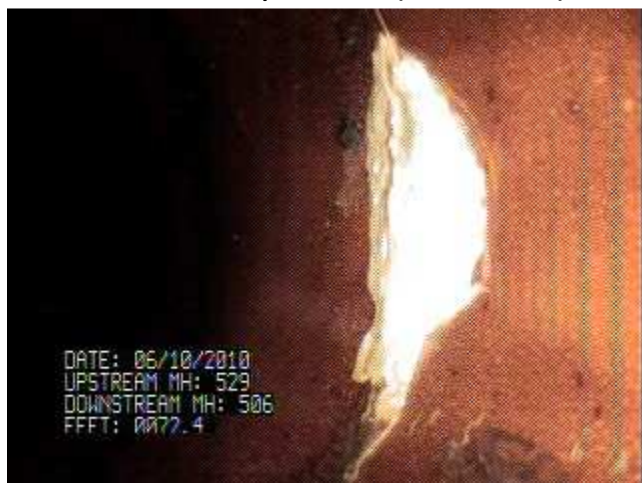
Mineral Deposit @ 72.4' (O&M Grade 2)

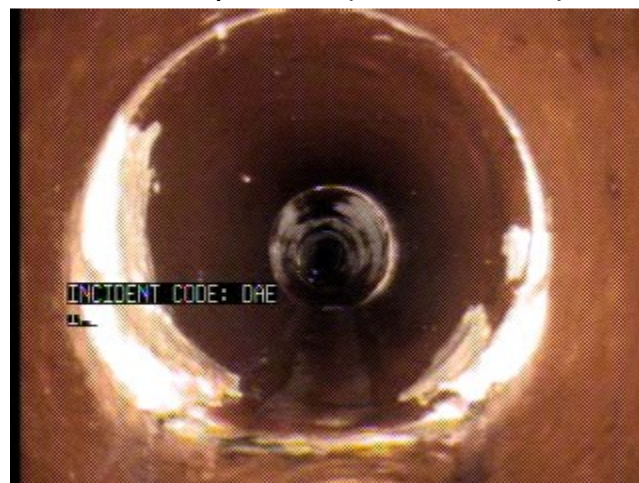
Mineral Deposit @ 125.3' (O&M Grade 2)

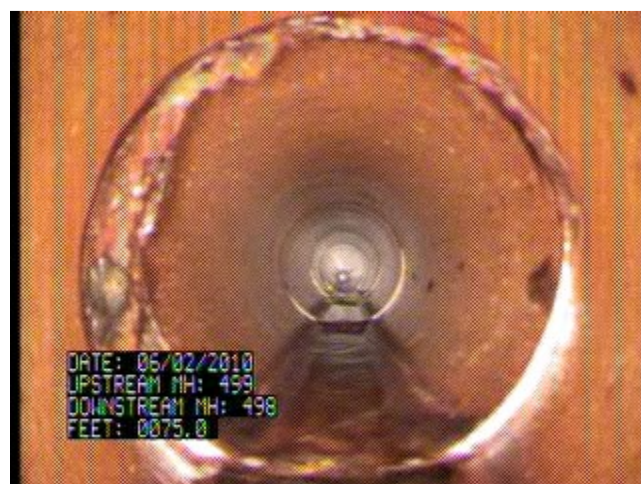
Mineral Deposit @ 75.0' (O&M Grade 2)

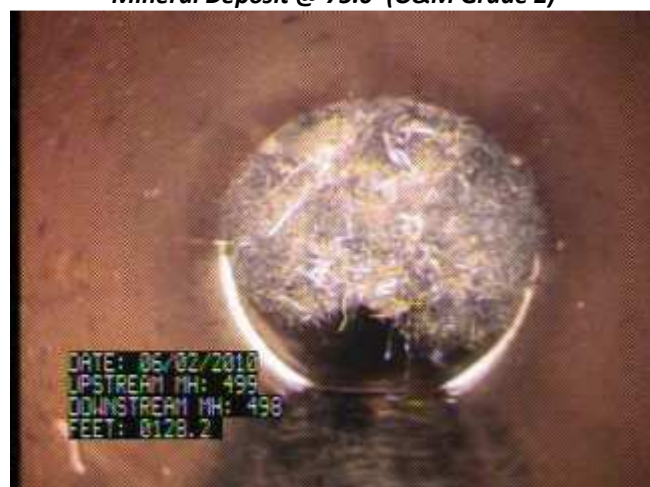
Root Ball in Joint @ 128.2' Requiring Heavy Cleaning

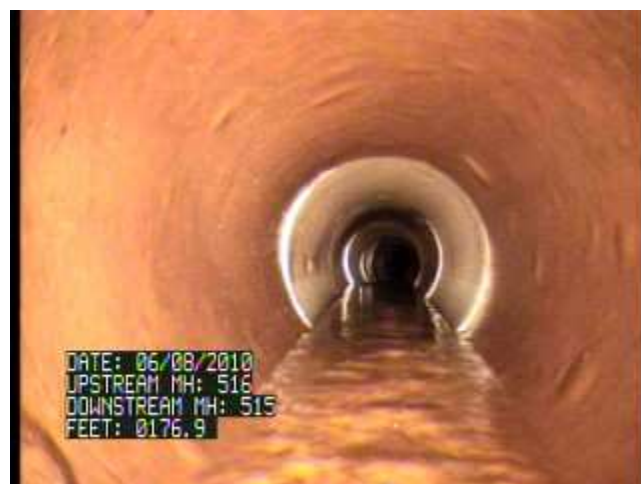
Sag in Line @ 176.9 (O&M Grade 2)

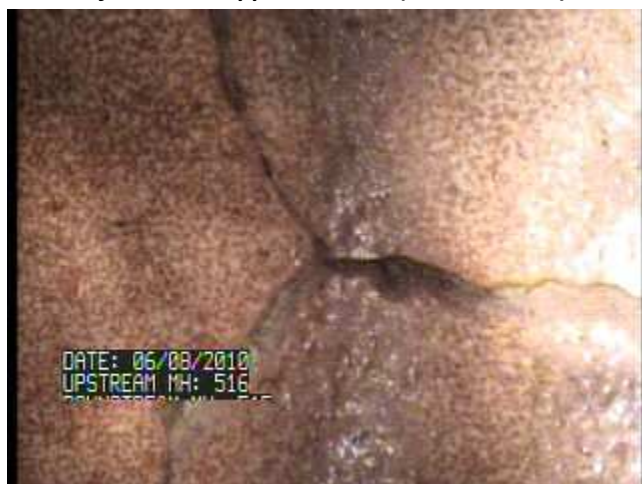
Crack Multiple @ 171.4' (Structural Grade 3)

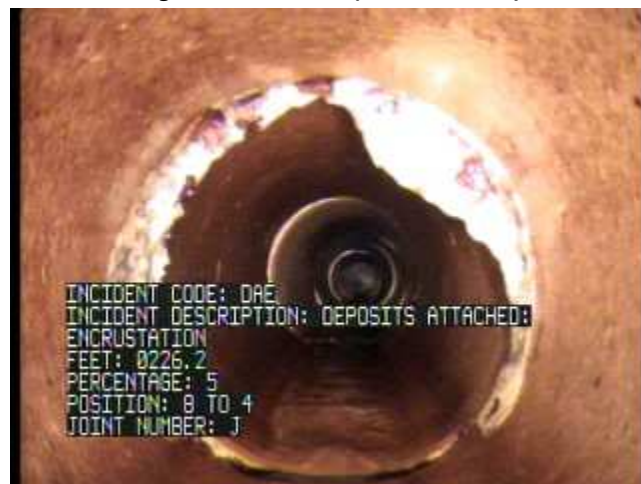
Mineral Deposit @ 226.2' (O&M Grade 2)

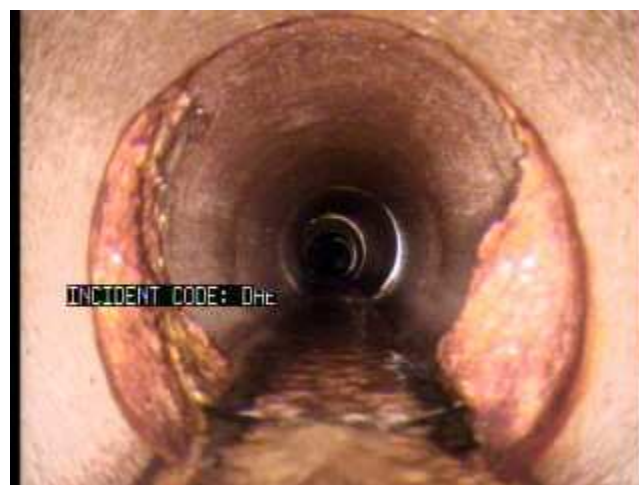
Mineral Deposit @ 236.8' (O&M Grade 2)

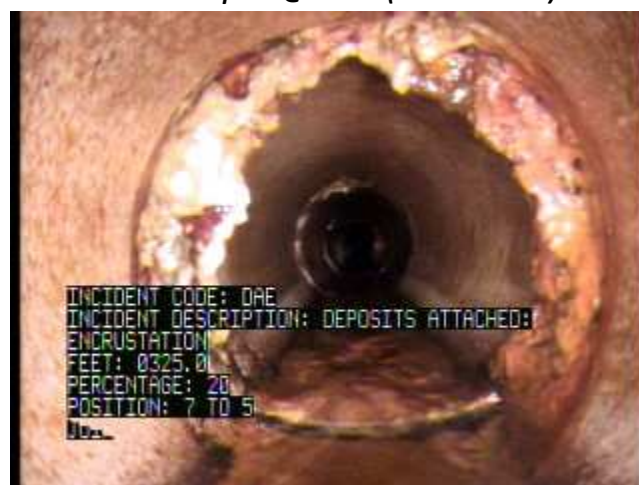
Mineral Deposit @ 325.0' (O&M Grade 3)

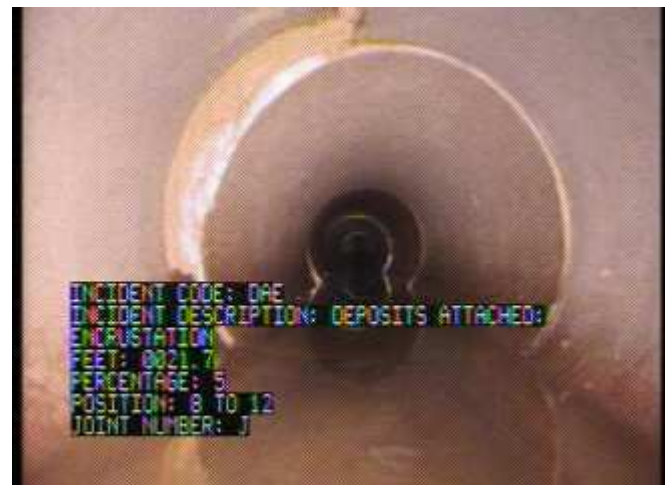
Mineral Deposit @ 21.7' (O&M Grade 2)

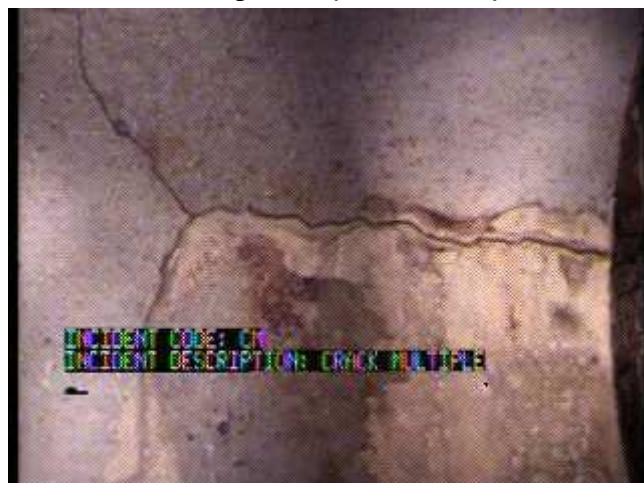
Crack multiple @ 22.8' (Structural Grade 3)

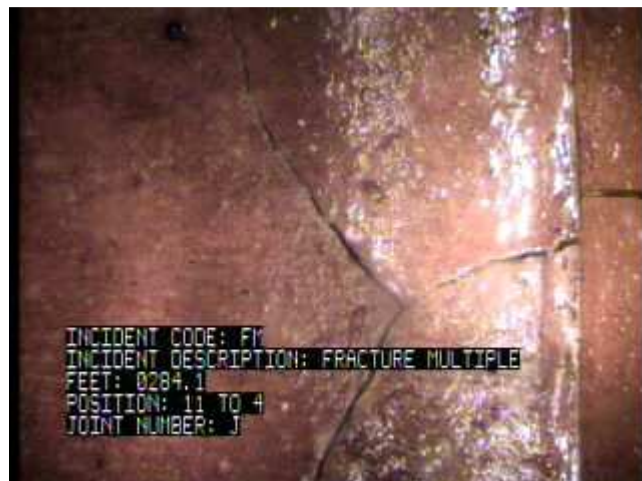
Fracture Multiple @ 284.1' (Structural Grade 4)

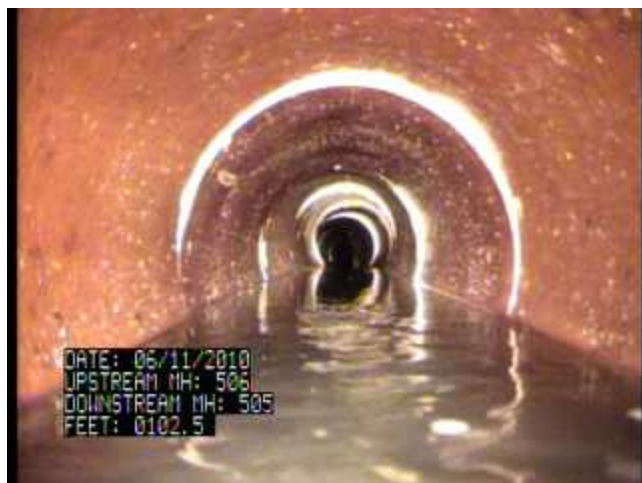
15% Sag @ 102.5' (O&M Grade 2)

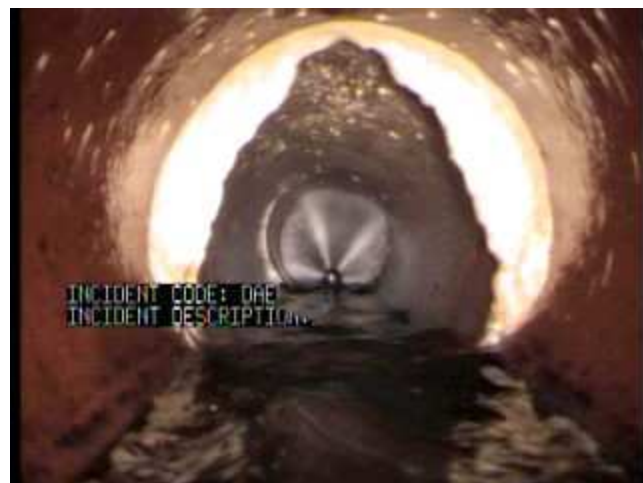
Mineral Deposit @ 169.4' (O&M Grade 3)

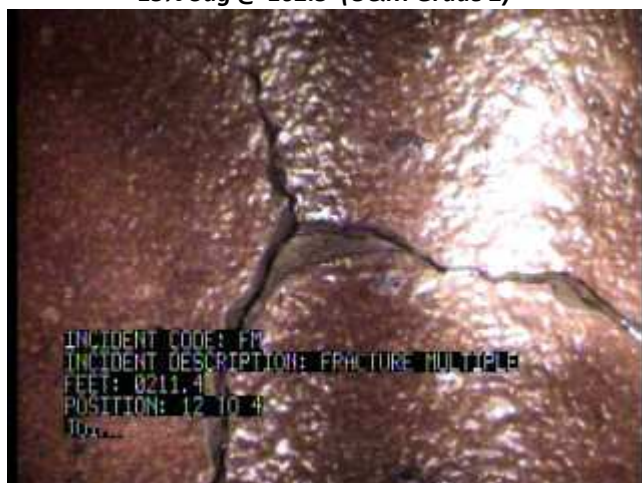
Fracture Multiple @ 211.4' – Structural Grade 4

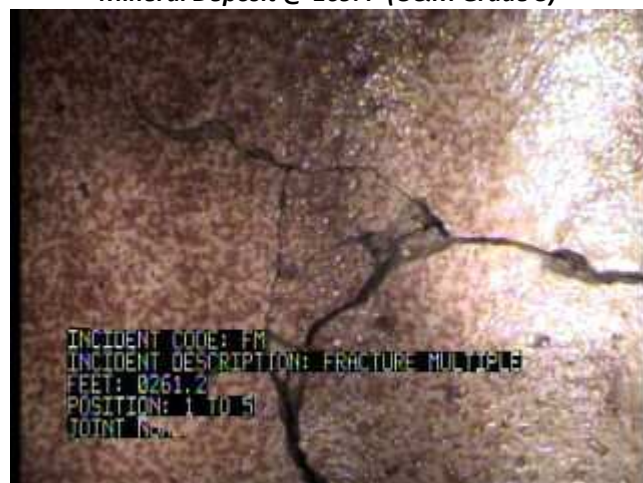
- **506:505** - The sewer inspection for pipe run 506:505 has shown that the pipe is in good condition with a Structural Score of 2.15, an O&M Score of 2.00, and a Composite Score of 2.11. The images below show some of the most severe defects encountered during the inspection. This line section is being recommended to be placed on a maintenance program where cleaning and inspection activities are completed once every 10 years. This will ensure that the structural defects are monitored in sufficient fashion that rehabilitation measures can be taken at an appropriate time. The maintenance program will also ensure that any mineral deposits significantly reducing the flowable cross-section are cut out, debris that has settled in a sag is removed, and all other O&M defects are addressed in like kind. During the inspection 6 of 7 laterals were found to have a continual stream of clear water discharging into the sanitary main; this may be a possible contributor to the I/I of the system. The homes tributary to this line is being recommended for future testing to determine if any I/I contribution exists.

Fracture Multiple @ 261.2 – Structural Grade 4

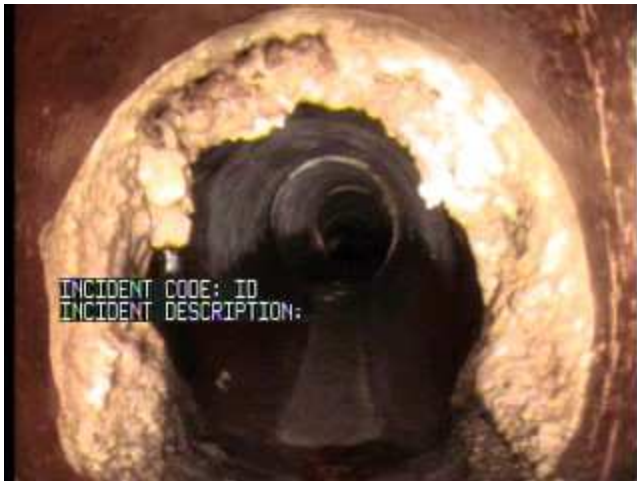
- **520:514** - The sewer inspection for pipe run 520:514 has shown that the pipe is in good condition with a Structural Score of 2.00, an O&M Score of 2.12, and a Composite Score of 2.11. The images below show some of the most severe defects encountered during the inspection. This line section is being recommended to be placed on a maintenance program where cleaning and inspection activities are completed once every 10 years. This will ensure that the pipe remains in good structural condition; the mineral deposits will be continually monitored and removed if they significantly reduce the flowable cross-section, and any other O&M issues are addressed in like kind. This line was identified as having 2 sources of I/I; special attention should be giving during future inspections of this line to note the existing sources of I/I, as well as to identify any other sources that may develop over time. During the inspection 9 of 13 laterals were found to have a continual stream of clear water discharging into the sanitary main; this may be a possible contributor to the I/I of the system. The homes tributary to this line is being recommended for future testing to determine if any I/I contribution exists.

Infiltration Dripper @ 31.7' (O&M Grade 3)

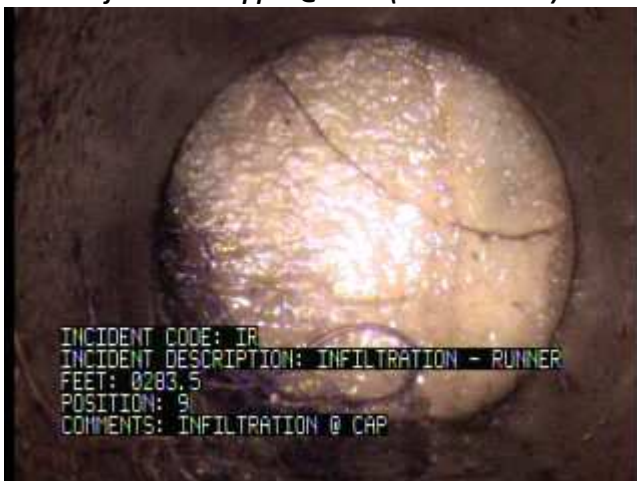
Infiltration Runner @ 283.5' (O&M Grade 4)

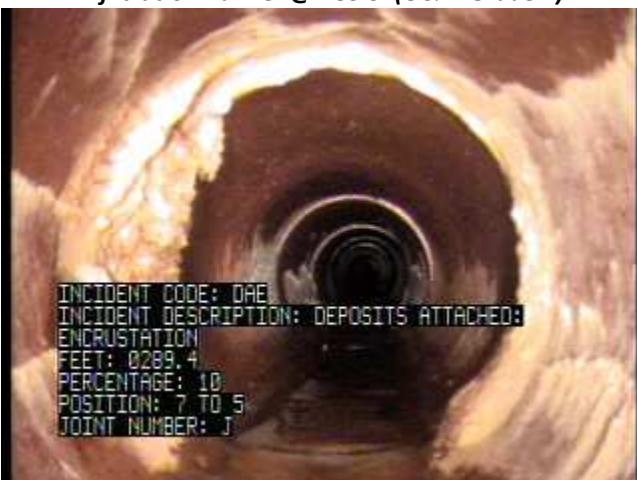
Mineral Deposit @ 289.4' (O&M Grade 2)

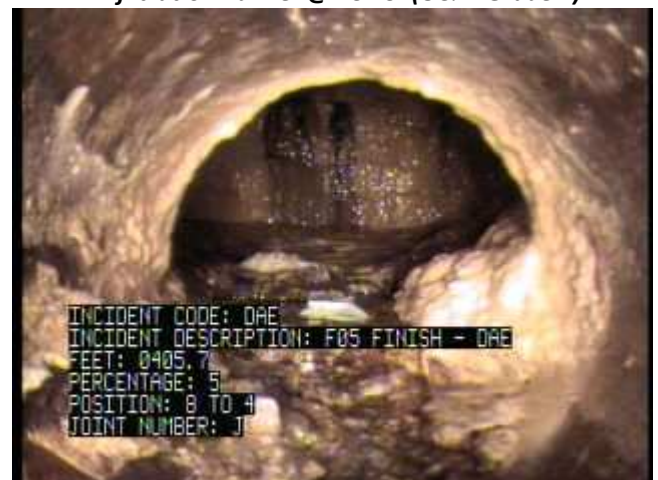
Mineral Deposit @ 405.7' (O&M Grade 4)

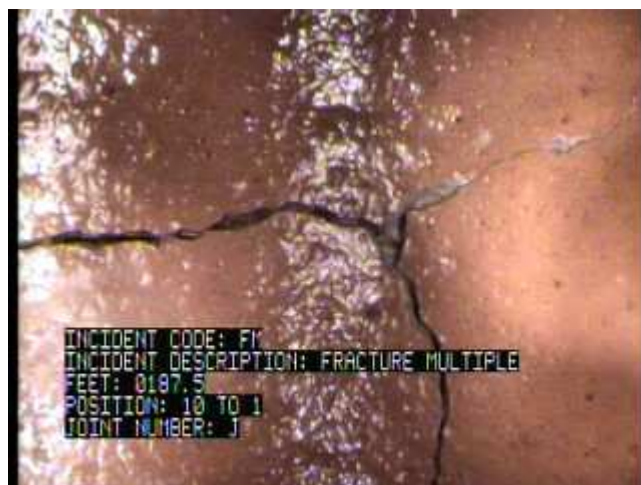
- **302:491** - The sewer inspection for pipe run 302:491 has shown that the pipe is in good condition with a Structural Score of 2.16, an O&M Score of 2.00, and a Composite Score of 2.12. The images below show some of the most severe defects encountered during the inspection. This line section is being recommended to be placed on a maintenance program where cleaning and inspection activities are completed once every 10 years. This will ensure that the structural defects are monitored in sufficient fashion that rehabilitation measures can be taken at an appropriate time. The maintenance program will also ensure that all O&M defects are monitored and addressed as necessary.

Fracture Multiple @ 187.5' (Structural Grade 4)

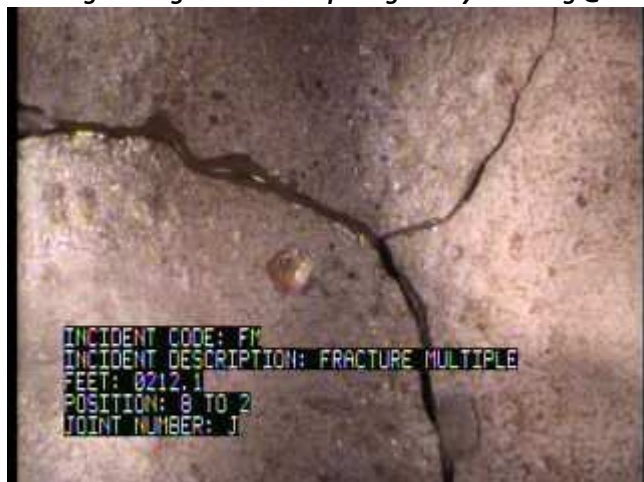
Fracture Multiple @ 212.1' (Structural Grade 4)

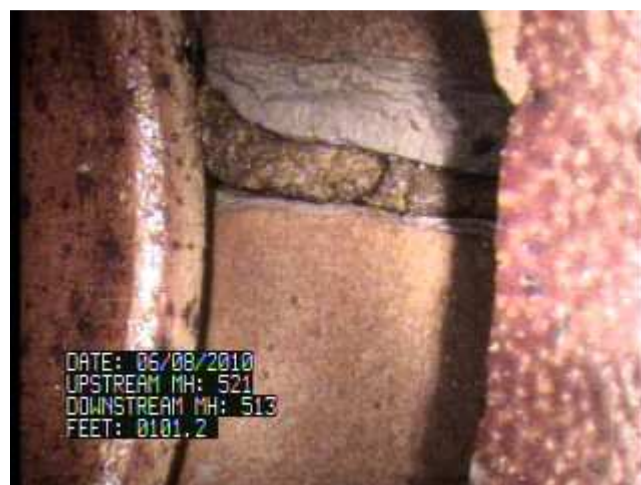
- **521:513** - The sewer inspection for pipe run 521:513 has shown that the pipe is in fair condition with a Structural Score of 2.27, an O&M Score of 2.12, and a Composite Score of 2.15. The images below show some of the most severe defects encountered during the inspection. This line section is being recommended to be placed on a maintenance program where cleaning and inspection activities are completed once every 5 years. This will ensure that the structural defects are monitored in sufficient fashion that rehabilitation measures can be taken at an appropriate time; the broken pipe, as shown below, appears to be held in place by the mortar poured around the joint and does not need to be repaired at this time. The maintenance program will also ensure that all mineral deposits are monitored and removed as necessary, in addition to all other O&M defects. This line was identified as having 2 sources of I/I; special attention should be giving during future inspections of this line to note the existing sources of I/I, as well as to identify any other sources that may develop over time. During the inspection 7 of 12 laterals were found to have a continual stream of clear water discharging into the sanitary main; this may be a possible contributor to the I/I of the system. The homes tributary to this line is being recommended for future testing to determine if any I/I contribution exists.

Broken Pipe @ 101.2' (Structural Grade 5)

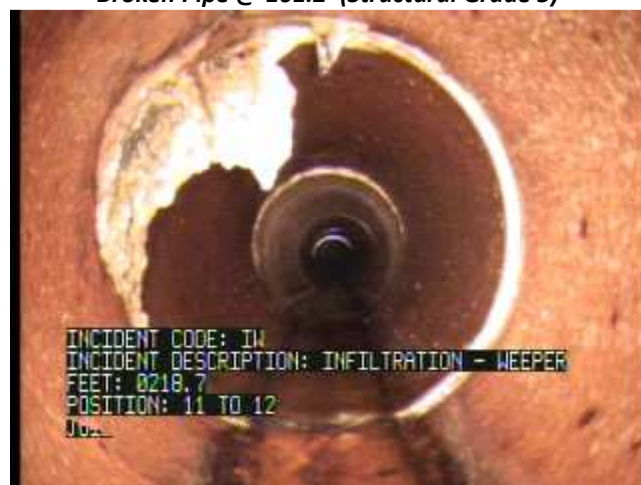
*Mineral Deposits @ 218.7' (O&M Grade 3)
Infiltration Weeper @ 218.7' (O&M Grade 2)*

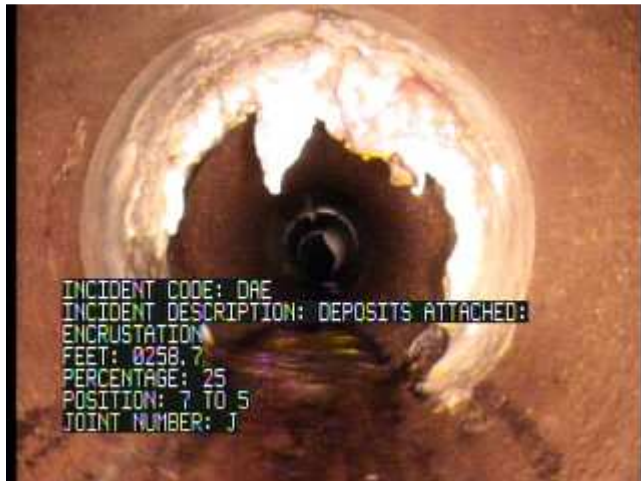
*Mineral Deposits @ 258.7' (O&M Grade 4)
Infiltration Dripper @ 258.7' (O&M Grade 3)*

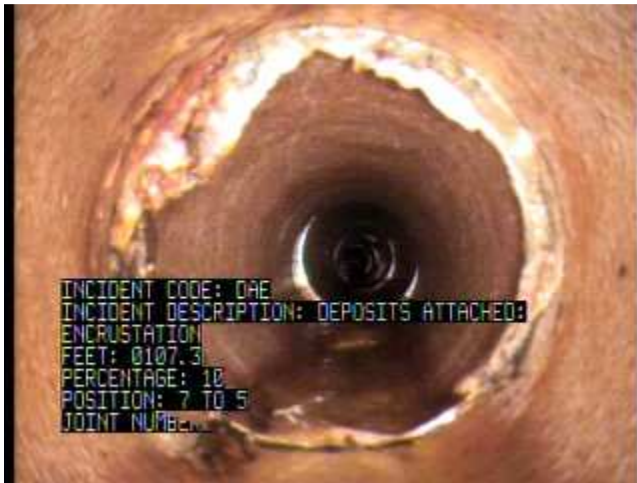
- **518:516** - The sewer inspection for pipe run 518:516 has shown that the pipe is in fair condition with a Structural Score of 2.38, an O&M Score of 2.11, and a Composite Score of 2.15. The images below show some of the most severe defects encountered during the inspection. This line section is being recommended to be placed on a maintenance program where cleaning and inspection activities are completed once every 5 years. This will ensure that the structural defects are monitored in sufficient fashion that rehabilitation measures can be taken at an appropriate time; after further inspection the hole at 323.2' appears to be an air bubble that was in the clay at the time the pipe was constructed and does not need repaired at this time. The maintenance program will also ensure that all mineral deposits are monitored and removed as necessary, in addition to all other O&M defects. This line was identified as having 2 sources of I/I; special attention should be giving during future inspections of this line to note the existing sources of I/I, as well as to identify any other sources that may develop over time. During the inspection 5 of 6 laterals were found to have a continual stream of clear water discharging into the sanitary main; this may be a possible contributor to the I/I of the system. The homes tributary to this line is being recommended for future testing to determine if any I/I contribution exists.

Mineral Deposits @ 107.3' (O&M Grade 2)

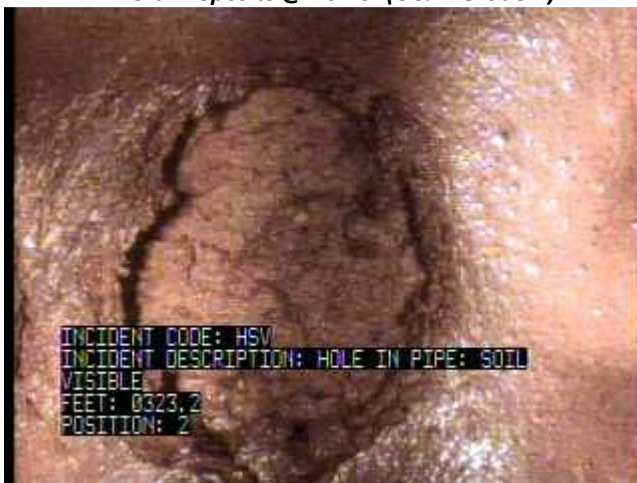
Hole in Pipe @ 323.2' (Structural Grade 5)

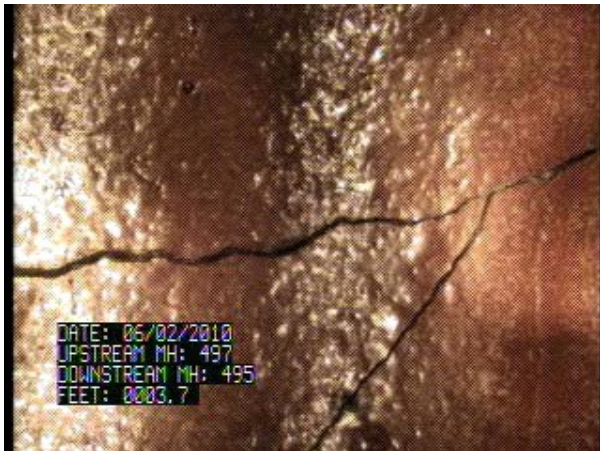
- **497:495** - The sewer inspection for pipe run 497:495 has shown that the is in fair condition with a Structural Score of 2.58, an O&M Score of 1.43, and a Composite Score of 2.17. The images below show some of the most severe defects encountered during the inspection. This line section is being recommended to be placed on a maintenance program where cleaning and inspection activities are completed once every 5 years. This will ensure that the structural defects are monitored in sufficient fashion that rehabilitation measures can be taken at an appropriate time. The maintenance program will also ensure that root intrusion, line sags, and all other O&M Defects are addressed in like kind. During the inspection 1 of 4 laterals was found to have a continual stream of clear water discharging into the sanitary main; this may be a possible contributor to the I/I of the system.

Fracture Multiple @ 203.7' (Structural Grade 4)

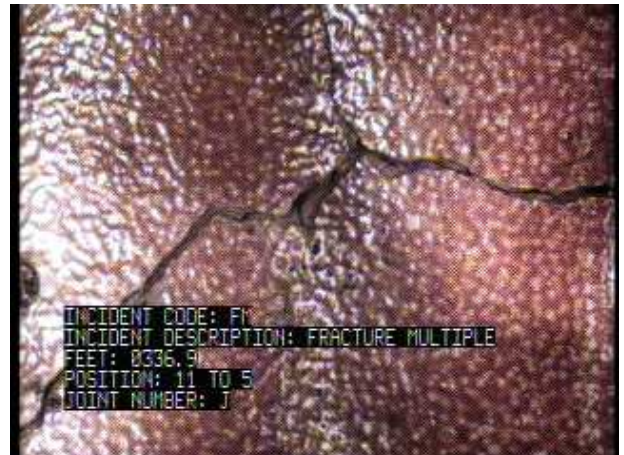
Fracture Multiple @ 336.9' (Structural Grade 4)

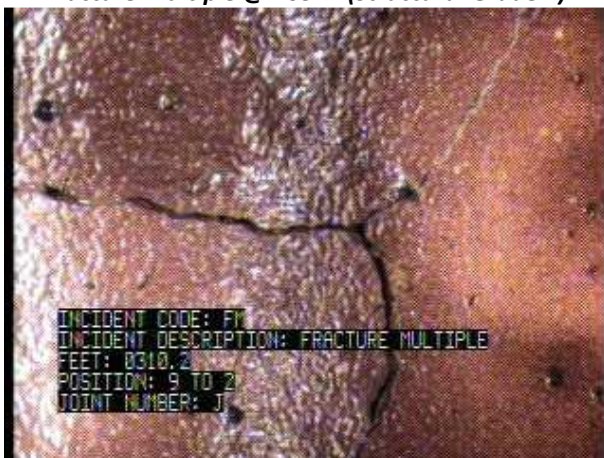
Fracture Multiple @ 310.2' (Structural Grade 4)

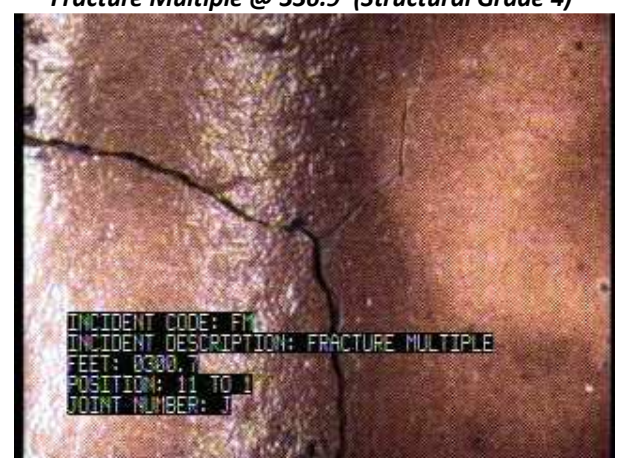
Fracture Multiple @ 300.7' (Structural Grade 4)

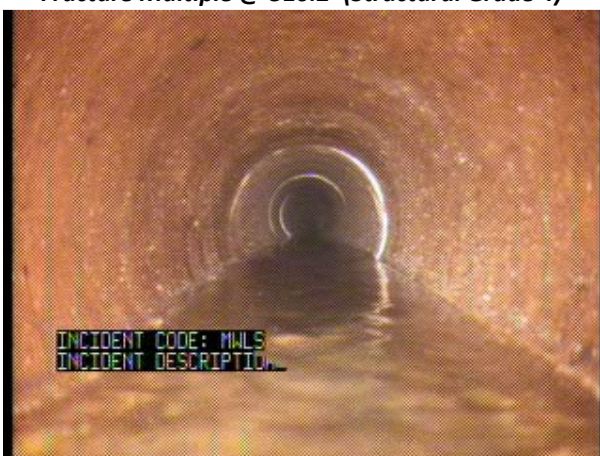
10% Sag @ 315.8' (O&M Grade 2)

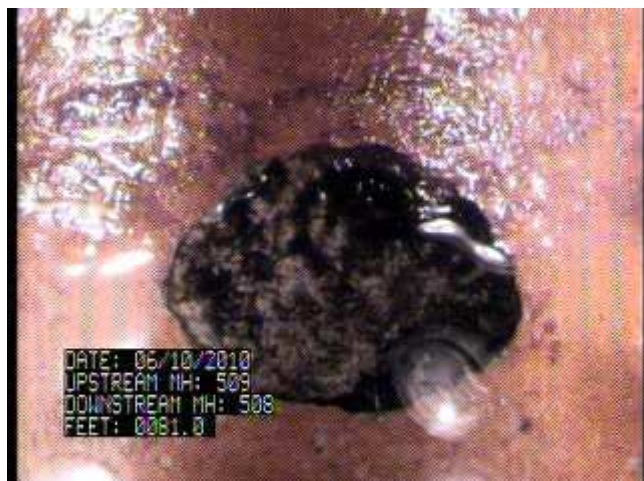
- **509:508** - The sewer inspection for pipe run 509:508 has shown that the pipe is in good condition with a Structural Score of 2.47, an O&M Score of 2.00, and a Composite Score of 2.19. The images below show some of the most severe defects encountered during the inspection. This line section is being recommended to be placed on a maintenance program where cleaning and inspection activities are completed once every 10 years. This will ensure that the structural defects are monitored in sufficient fashion that rehabilitation measures can be taken at an appropriate time; the hole in pipe and broken pipe, as shown below, appear to be reinforced by a cementitious material and do not need to be repaired at this time. The maintenance program will also ensure that all mineral deposits are monitored and removed as necessary, in addition to all other O&M defects. This line was identified as having 1 source of I/I; special attention should be giving during future inspections of this line to note the existing source of I/I, as well as to identify any other sources that may develop over time. During the inspection 1 of 7 laterals was found to have a continual stream of clear water discharging into the sanitary main; this may be a possible contributor to the I/I of the system.

Hole in Pipe @ 81.0' (Structural Grade 5)

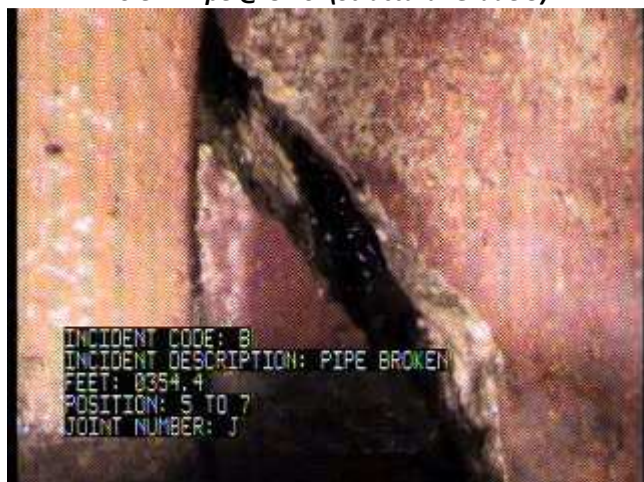
Broken Pipe @ 254.4' (Structural Grade 5)

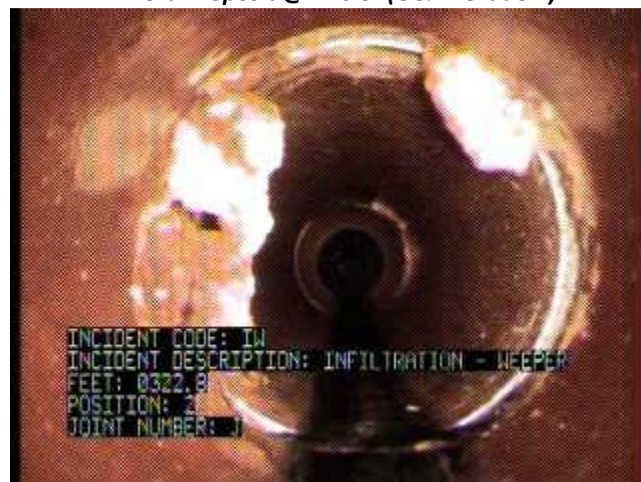
*Infiltration Weeper @ 322.8' (O&M Grade 2)
Mineral Deposit @ 322.8' (O&M Grade 3)*

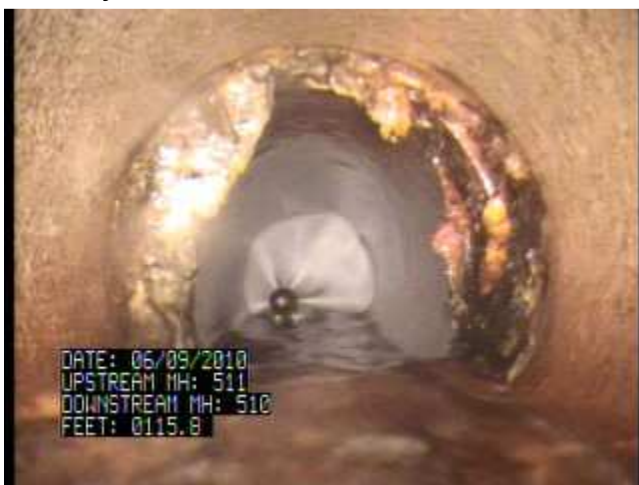
Mineral Deposit @ 115.8' (O&M Grade 4)

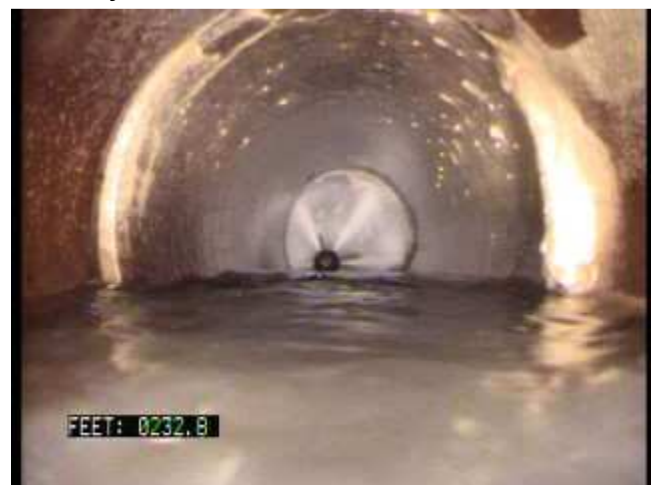
Mineral Deposit @ 232.8 (O&M Grade 2)

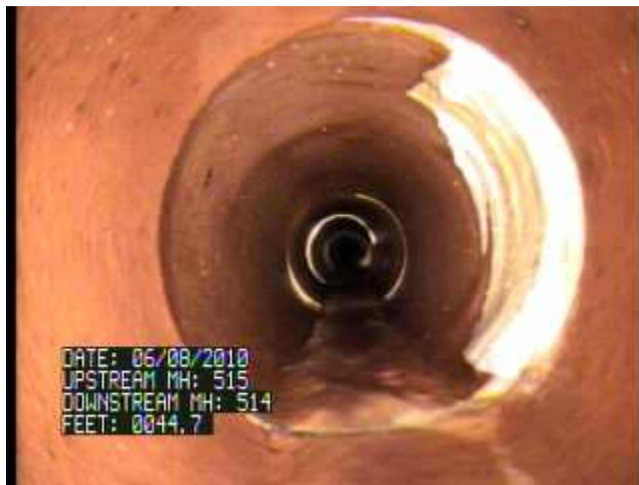
- **515:514** - The sewer inspection for pipe run 515:514 has shown that the pipe is in fair condition with a Structural Score of 2.71, an O&M Score of 2.00, and a Composite Score of 2.20. The images below show some of the most severe defects encountered during the inspection. This line section is being recommended to be placed on a maintenance program where cleaning and inspection activities are completed once every 5 years. This will ensure that the structural defects are monitored in sufficient fashion that rehabilitation measures can be taken at an appropriate time. It is recommended that the broken pipe at the end of the run, see picture below, be repaired with a 10' Cast In Place Pipe (CIPP) sectional liner. The maintenance program will also ensure that mineral deposits are monitored and removed as necessary and all other O&M defects are addressed in like kind. During the inspection 3 of 4 laterals were found to have a continual stream of clear water discharging into the sanitary main; this may be a possible contributor to the I/I of the system. The homes tributary to this line is being recommended for future testing to determine if any I/I contribution exists.

Mineral Deposit @ 44.7' (O&M Grade 2)

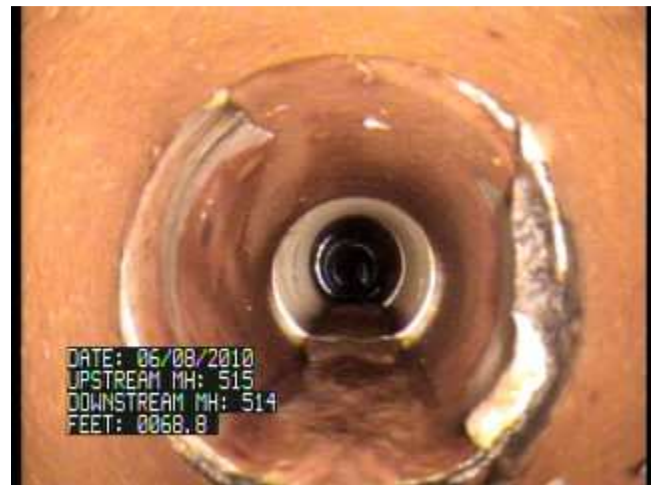
Mineral Deposit @ 68.8' (O&M Grade 2)

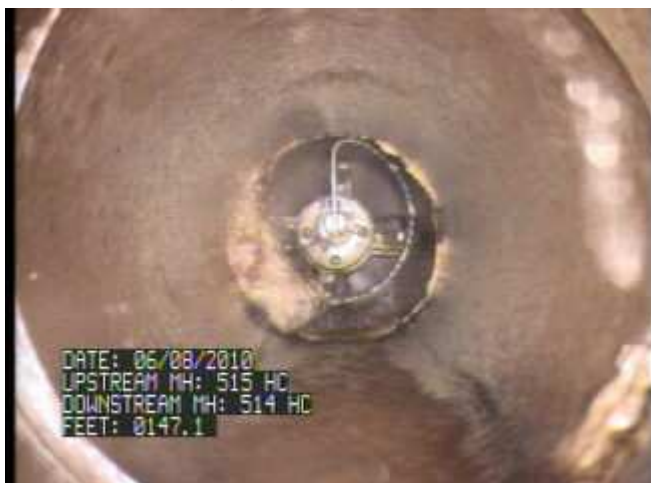
Mineral Deposit Requiring Heavy Cleaning @ 147.1'

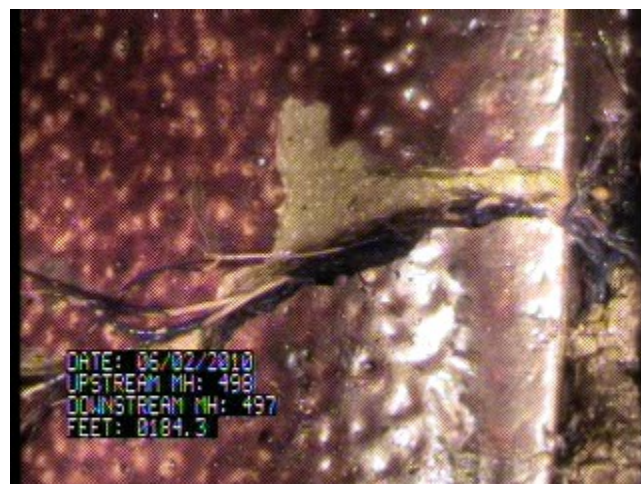
Fracture Longitudinal @ 184.3' (Structural Grade 3)
Fine Roots in Joint @ 184.3' (O&M Grade 1)

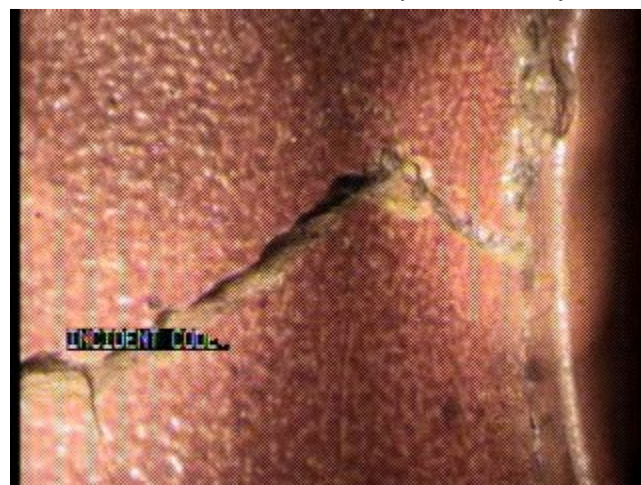
Fracture Longitudinal @ 1825.3' (Structural Grade 3)

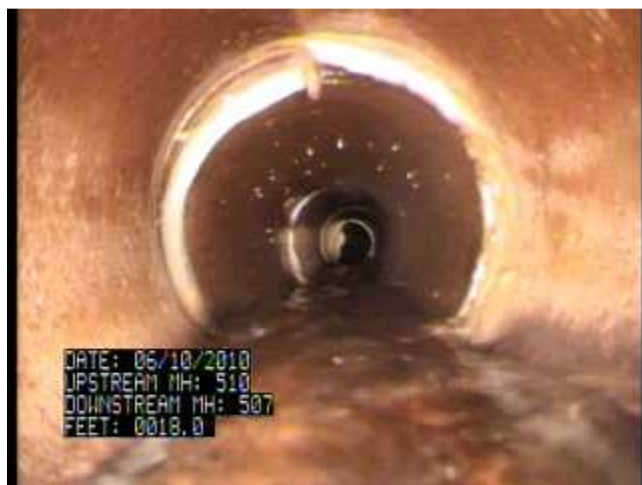
- **510:507** - The sewer inspection for pipe run 511:510 has shown that the is in fair condition with a Structural Score of 2.46, an O&M Score of 2.11, and a Composite Score of 2.25. The images below show some of the most severe defects encountered during the inspection. This line section is being recommended to be placed on a maintenance program where cleaning and inspection activities are completed once every 5 years. This will ensure that the pipe remains in good structural condition, while monitoring and removing mineral deposits and all other O&M Defects. This line was identified as having 3 sources of I/I; special attention should be giving during future inspections of this line to note the existing sources of I/I, as well as to identify any other sources that may develop over time.

*Infiltration Weeper @ 18.0' (O&M Grade 2)
Mineral Deposits @ 18.0' (O&M Grade 2)*

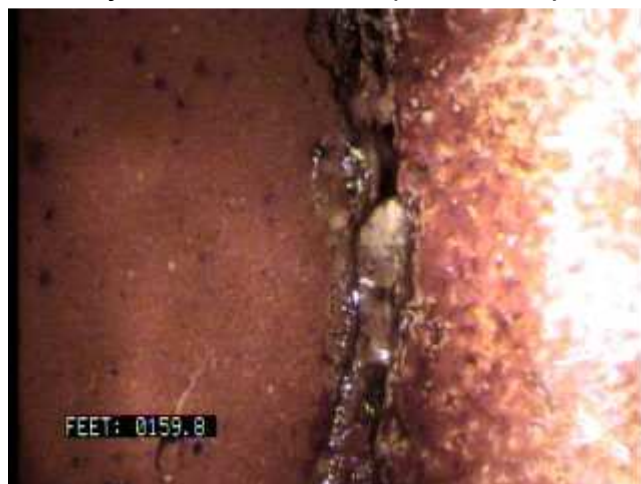
Infiltration Runner @ 159.8' (O&M Grade 4)

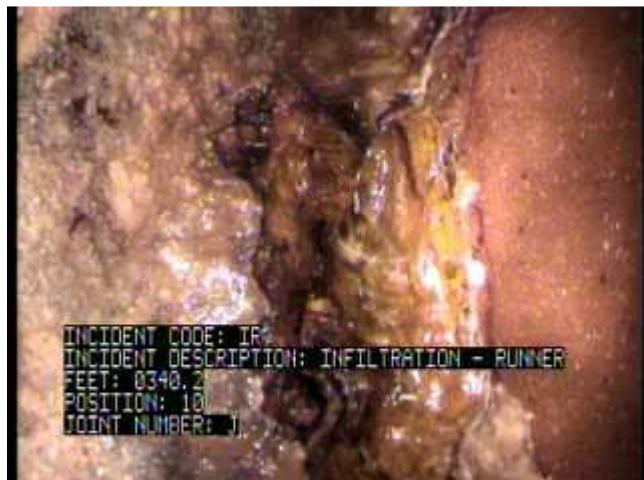
Infiltration Runner @ 340.2' (O&M Grade 4)

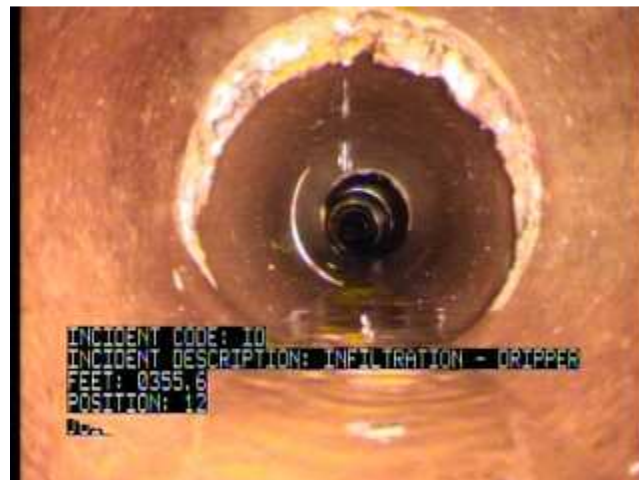
Infiltration Dripper @ 355.6' (O&M Grade 3)

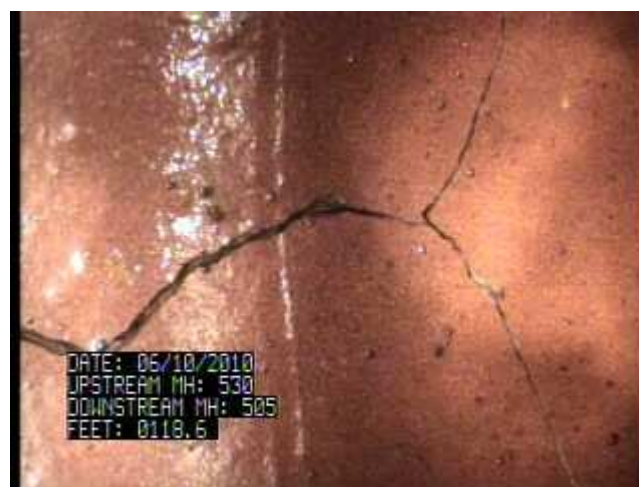
Fracture Multiple @ 118.6' (Structural Grade 4)

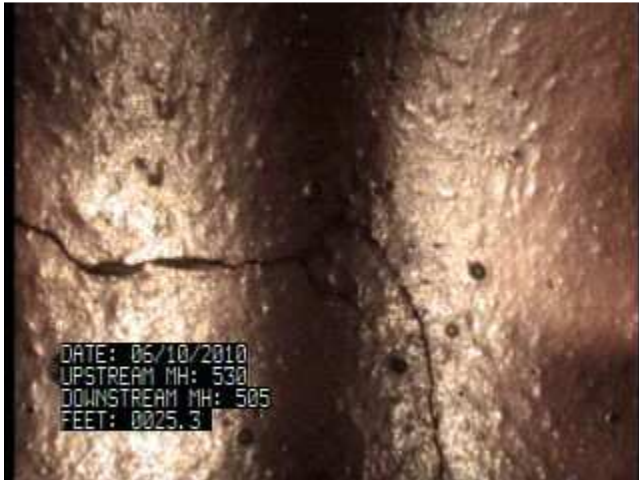
Crack Multiple @ 25.3' (Structural Grade 3)

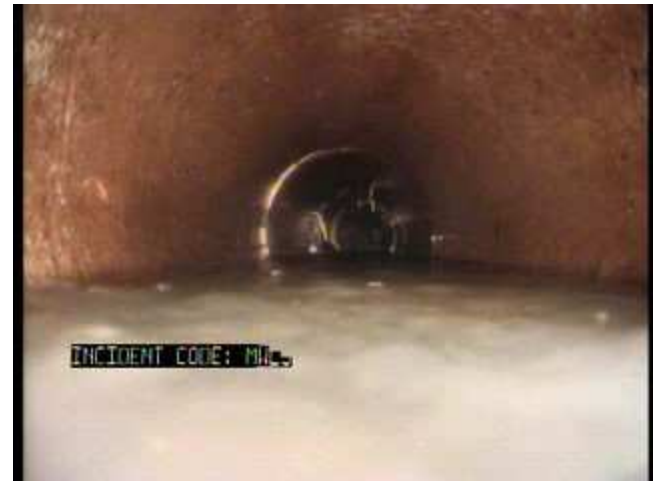
30% Sag @ 15.2' (O&M Grade 2)

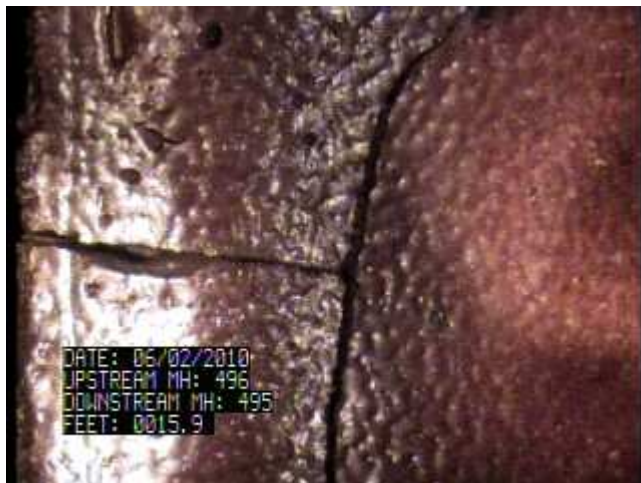
Fracture Multiple @ 15.9' (Structural Grade 4)
