Appendix B

Project Objective

Village of Riverlea, Ohio

Sanitary Sewer Evaluation Study

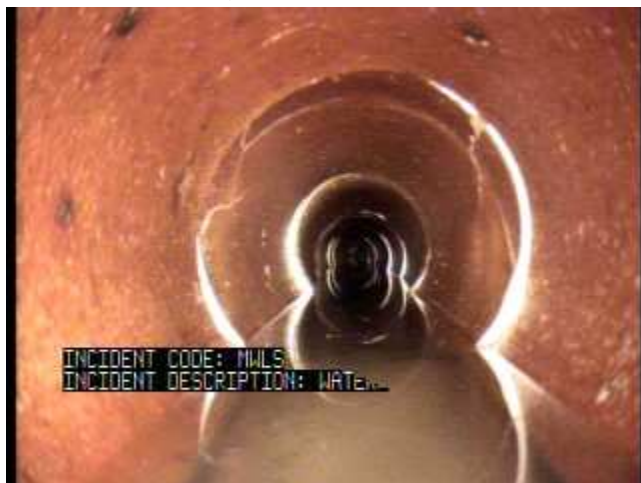
10% Sag @ 128.3' (O&M Grade 2)

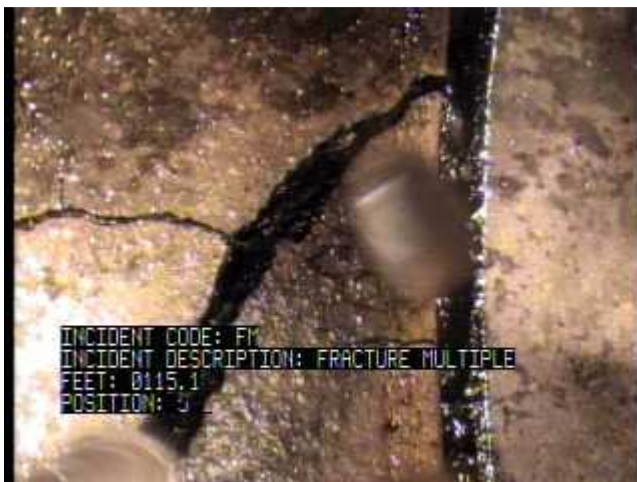
Fracture Multiple @ 115.1' (Structural Grade 4)

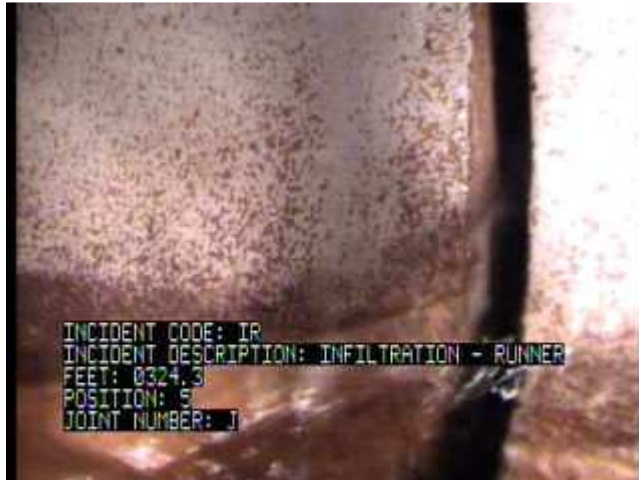
Infiltration Runner @ 324.3 (Structural Grade 4)

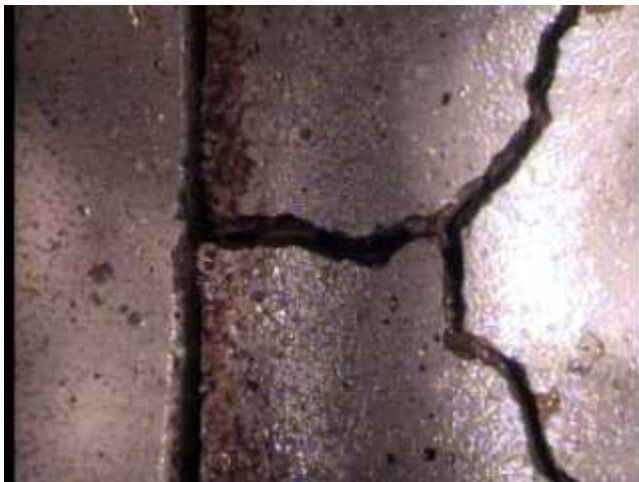
Fracture Multiple @ 98.2' (Structural Grade 4)

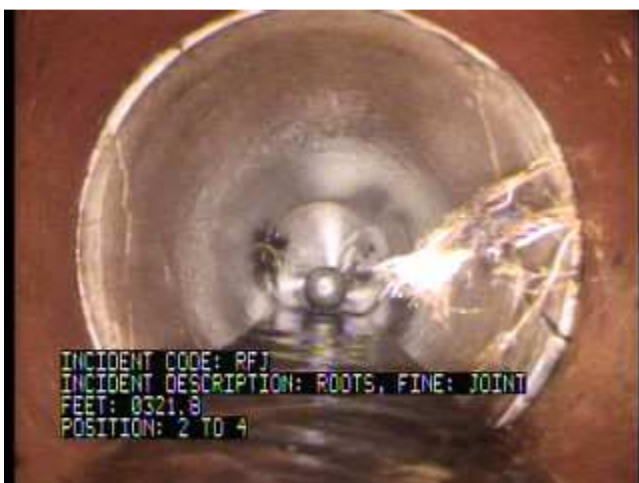
Fine Roots in Joint @ 321.8' (O&M Grade 1)

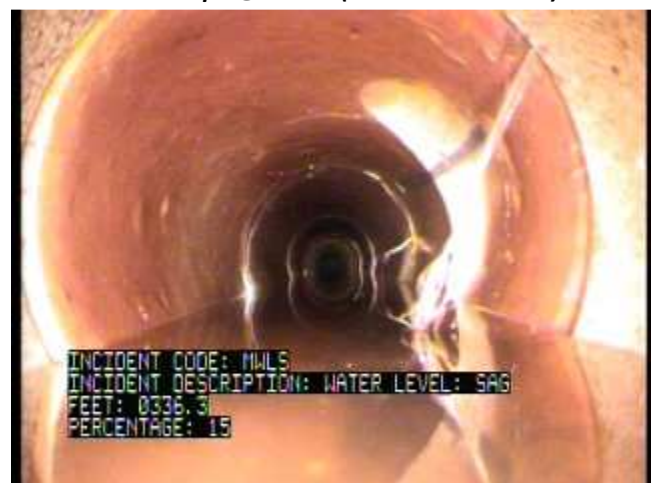
15% Sag in Line @336.3 (O&M Grade 2)

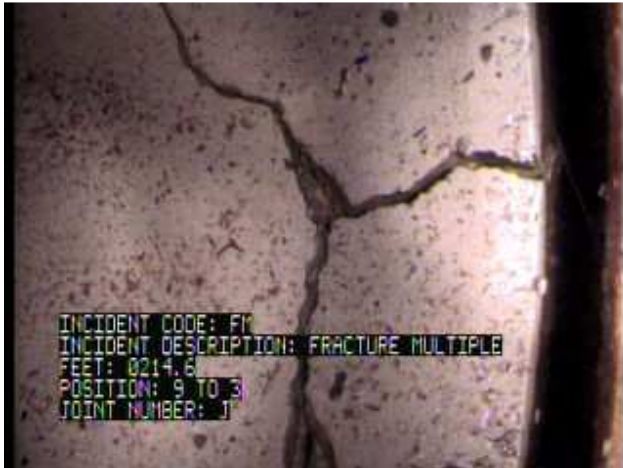
Fracture Multiple @ 214.6' (Structural Grade 4)

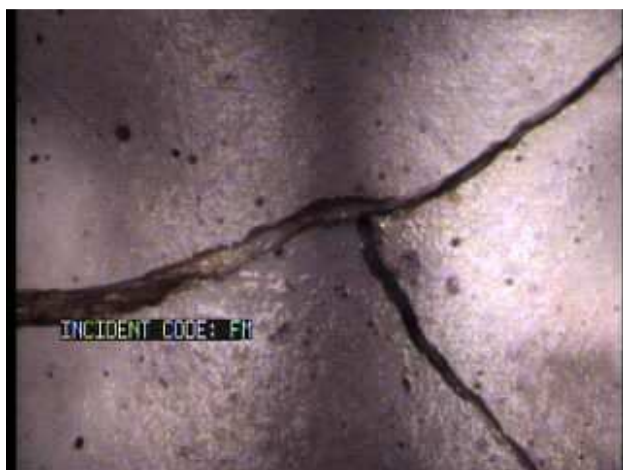
Fracture Multiple @ 18.1' (Structural Grade 4)

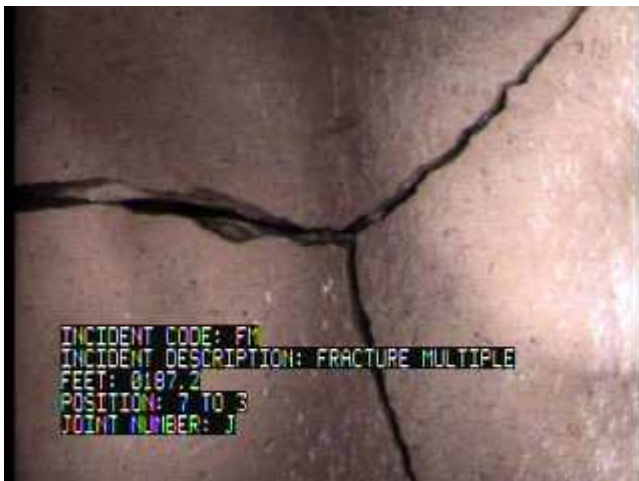
Fracture Multiple @ 187.2' (Structural Grade 4)

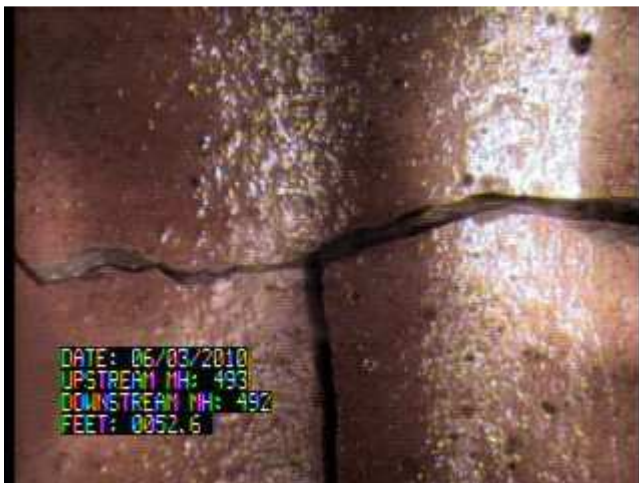
Fracture Multiple @ 52.6' (Structural Grade 4)

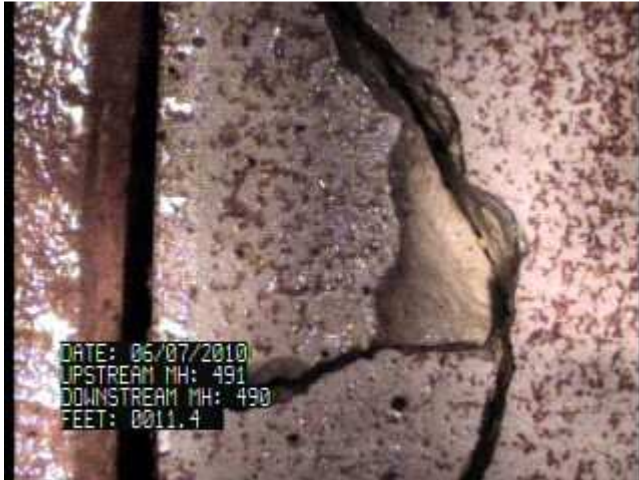
Fracture Multiple @ 11.4' (Structural Grade 4)

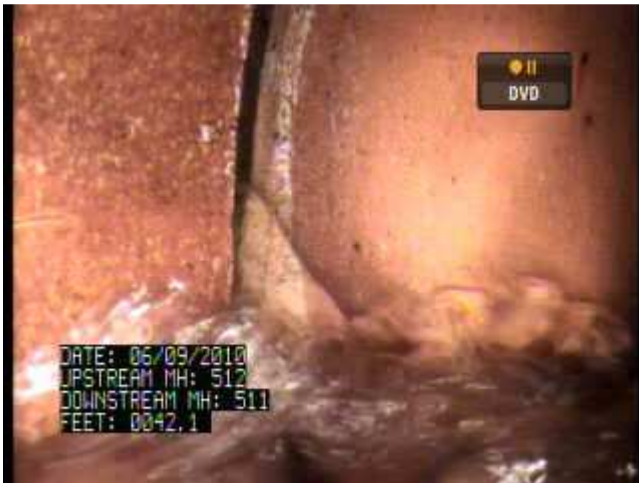
Infiltration Runner @ 42.1' (O&M Grade 4)

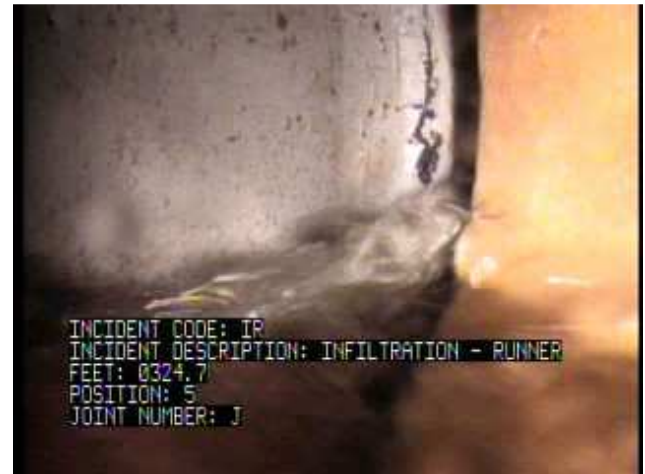
Infiltration Runner @ 324.7' (O&M Grade 4)

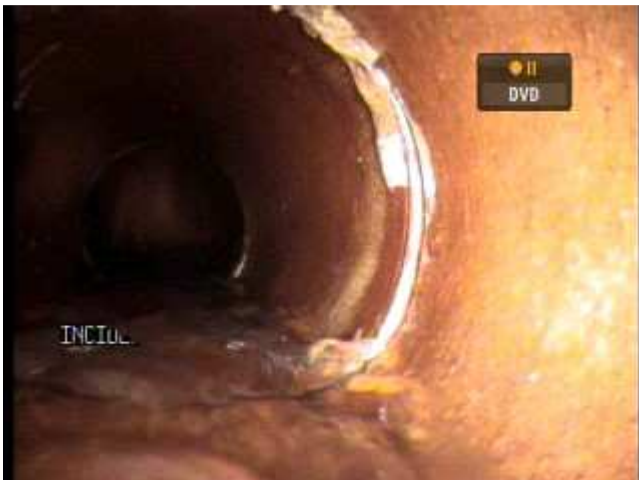
Infiltration Runner @ 53.9' (O&M Grade 4)

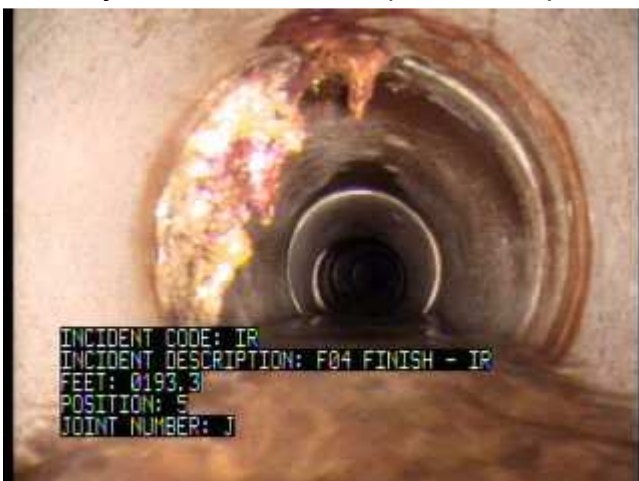
Infiltration Runner @ 193.3' (O&M Grade 4)
Mineral Deposit @ 193.3' (O&M Grade 2)
